Heritage Advisory Panel Report For the Meeting of June 11, 2024

To: Heritage Advisory Panel **Date:** June 7th, 2024
From: Kristal Stevenot, Senior Heritage Planner
Subject: **Heritage Alteration Permit with Variances Application No. 00036 and Rezoning Application No. 00869 for 1244 Wharf Street**

YATES BLOCK

1244 WHARF STREET, VICTORIA, BC

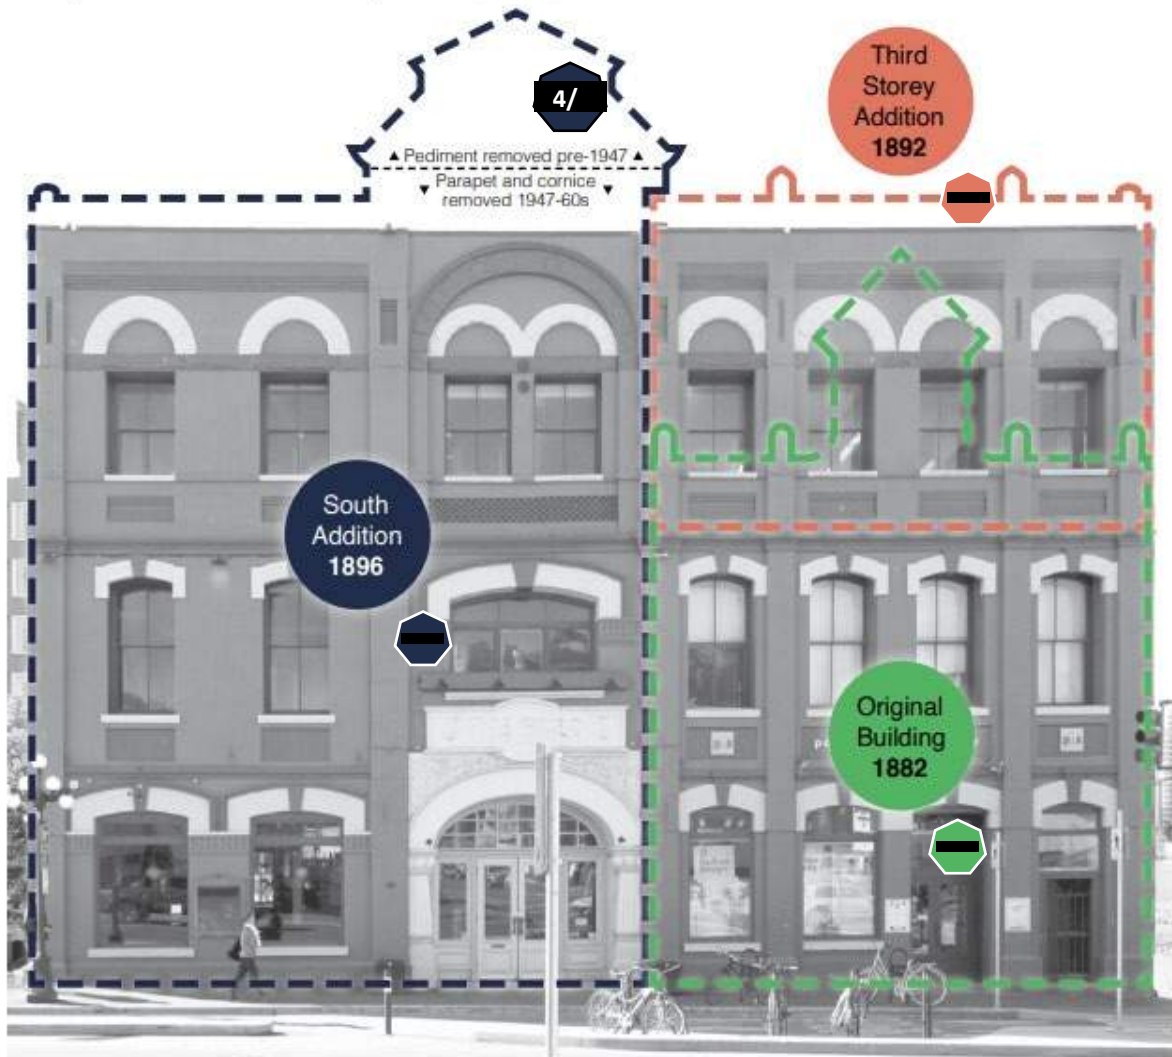
The three primary construction stages of the Yates Block. The pediment and parapet were removed at separate times.

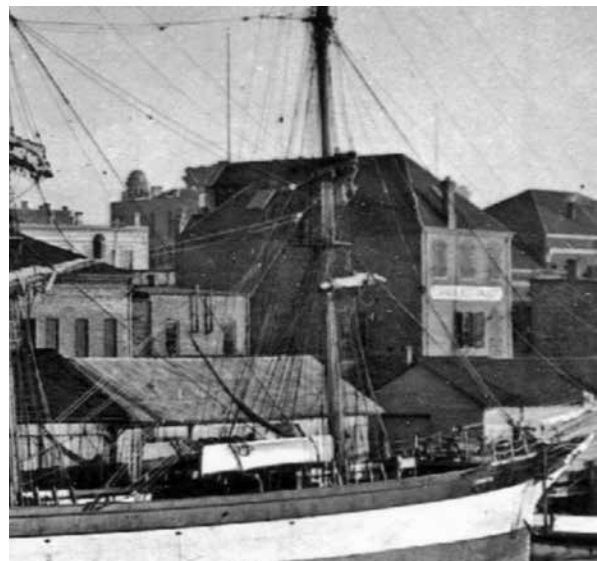
View of the rear and north elevation of the Yates Block in the 1880s, showing its original hip roof. (British Columbia Archives A-03848)

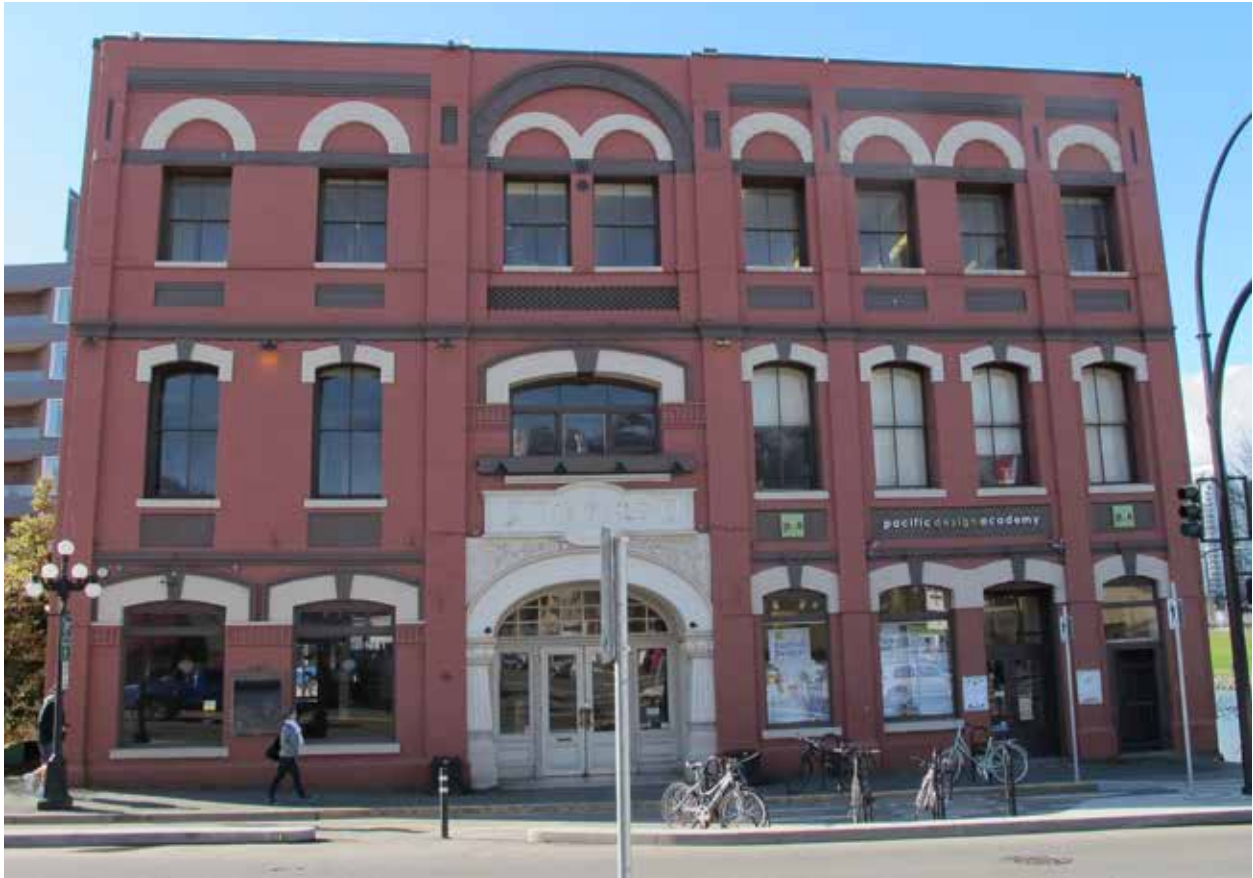
Front elevation of the Yates Block showing multi-wythe brick walls with brick and stone detailing.

The Yates Block features original masonry construction with stone foundation, multi-wythe red brick walls with stone detailing at the third floor of the front elevation. The brick on the side and rear elevations is laid in common bond with the segmental arch window openings possessing bonded arch lintels on the upper floors of the rear of the block. The front elevation is ornamented with both brick and stone details. Brick of the front elevation is laid in common bond with brick pilasters separating the five structural bays. The front elevation is further augmented through the presence of: recessed brick panels some parged and some unparged with corbelling; parged brick window hoods with keystones; brick drip moulds (ground level windows and second floor window above entry of 1896 addition); brick corbelling at the parapet between pilasters of four structural

Based on preliminary visual condition assessment, the brick and stone appears to be in good to fair condition; however, later interventions significantly limit the ability to review the masonry exterior of the block. The front (east) and rear (west) elevations have been painted which obscures the condition of the stone, brick, and mortar of those elevations.

- Preserve original exterior masonry walls.
- Restore parapet using available archival images as guides.
- Design structural or seismic upgrades, if required, so as to minimize the impact to the character-defining elements.

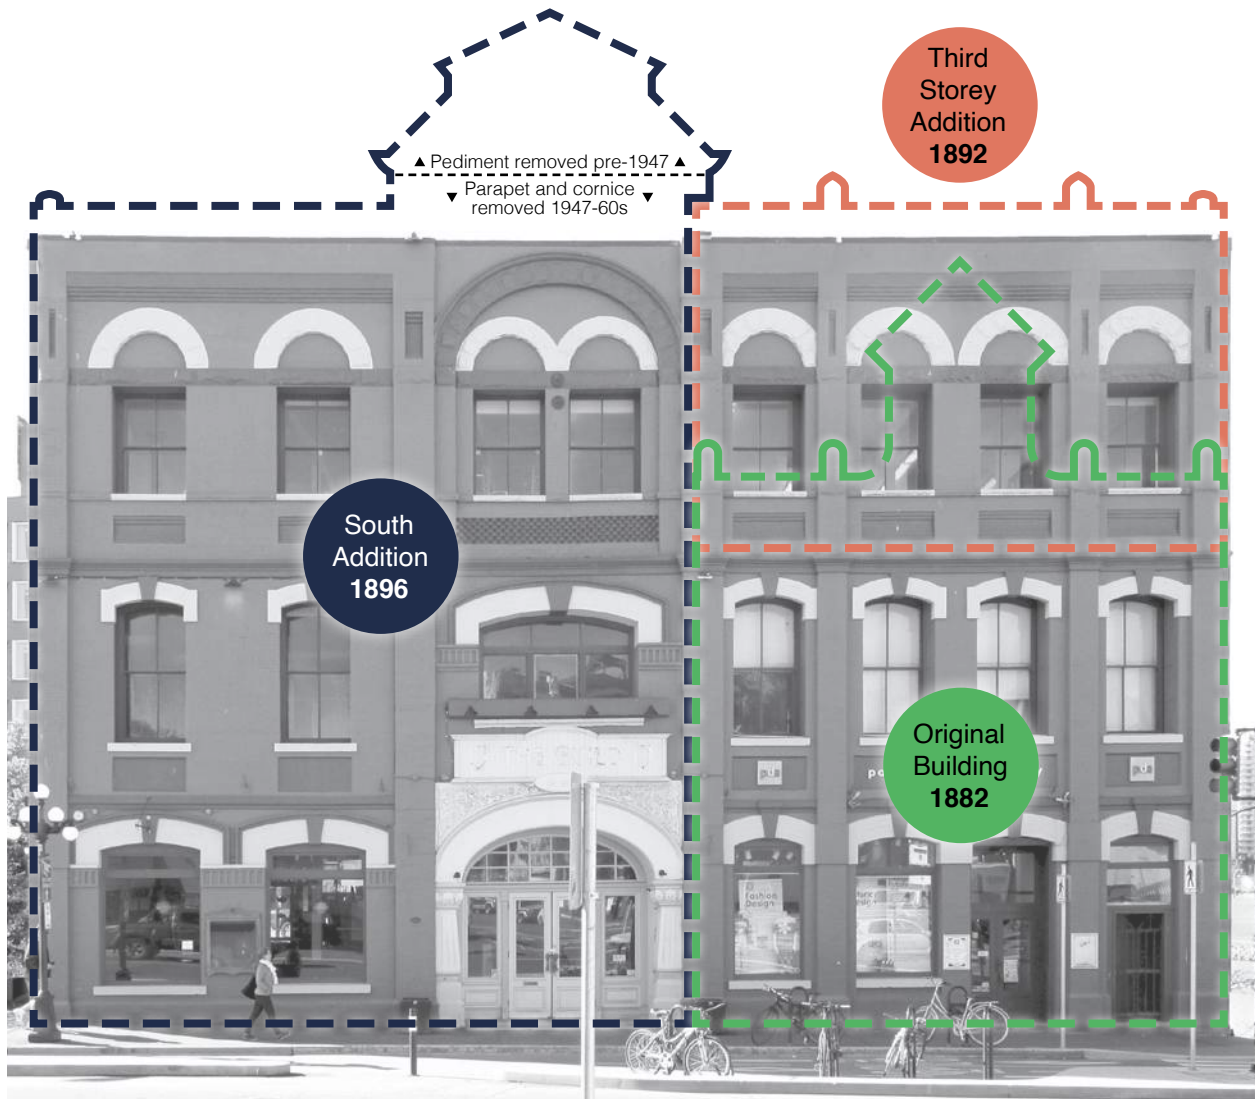
the third stage of the building was constructed, a three-storey addition at the south wall of the block. The materials, detailing, fenestration placement of the 1896 addition were designed to match the architecture of the 1882 and 1892 portion of the block. The 1896 addition altered the symmetry of the front elevation of the building changing it to an asymmetrical facade with off-centre main entry. Also as part of the 1896 construction, a parapet and substantial metal cornice with off-centre pediment were constructed.

The three primary construction stages of the Yates Block. The pediment and parapet were removed at separate times.

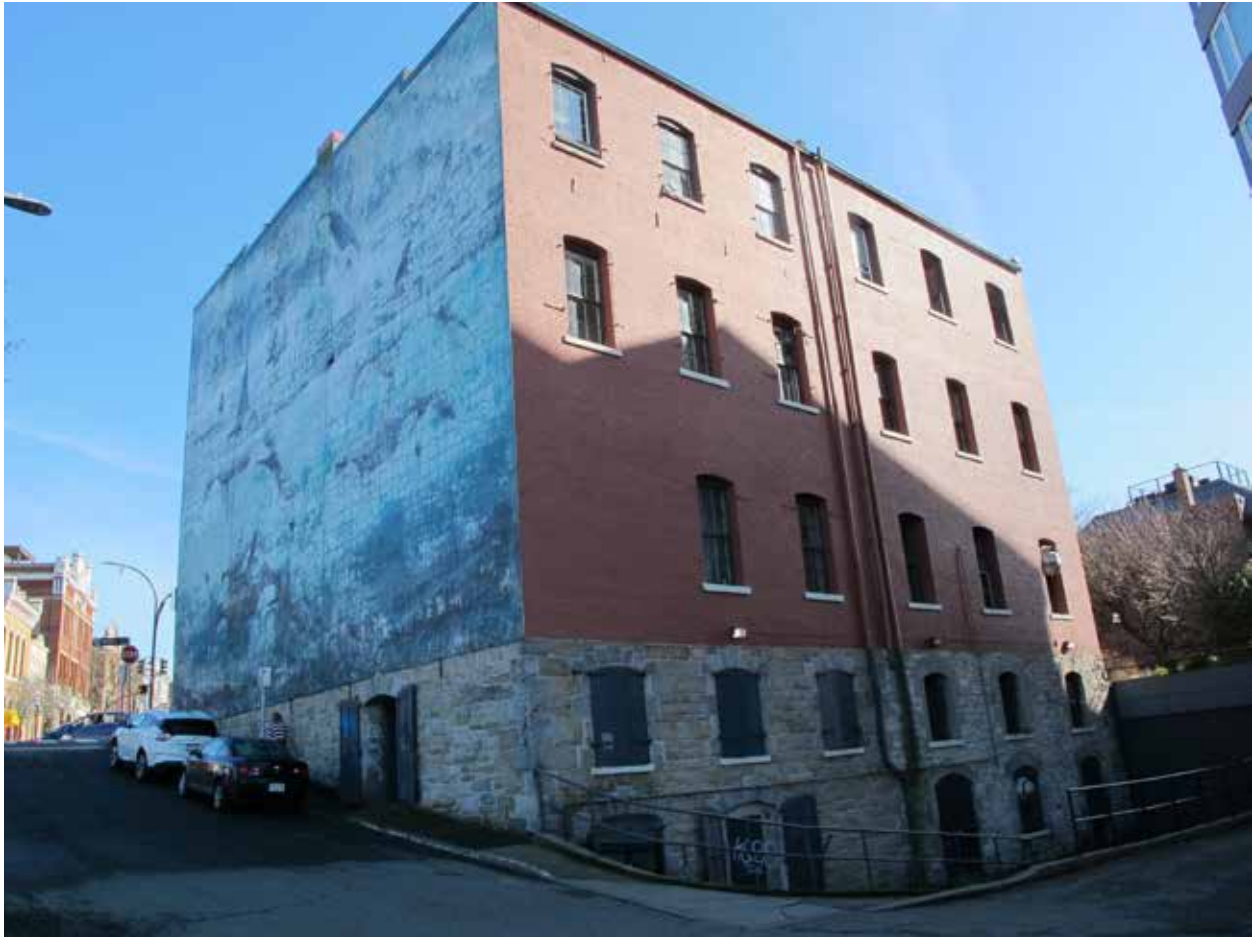
Rear (right) and north (left) elevations of the Yates Block showing painted brick on rear elevation and painted mural installation on north elevation

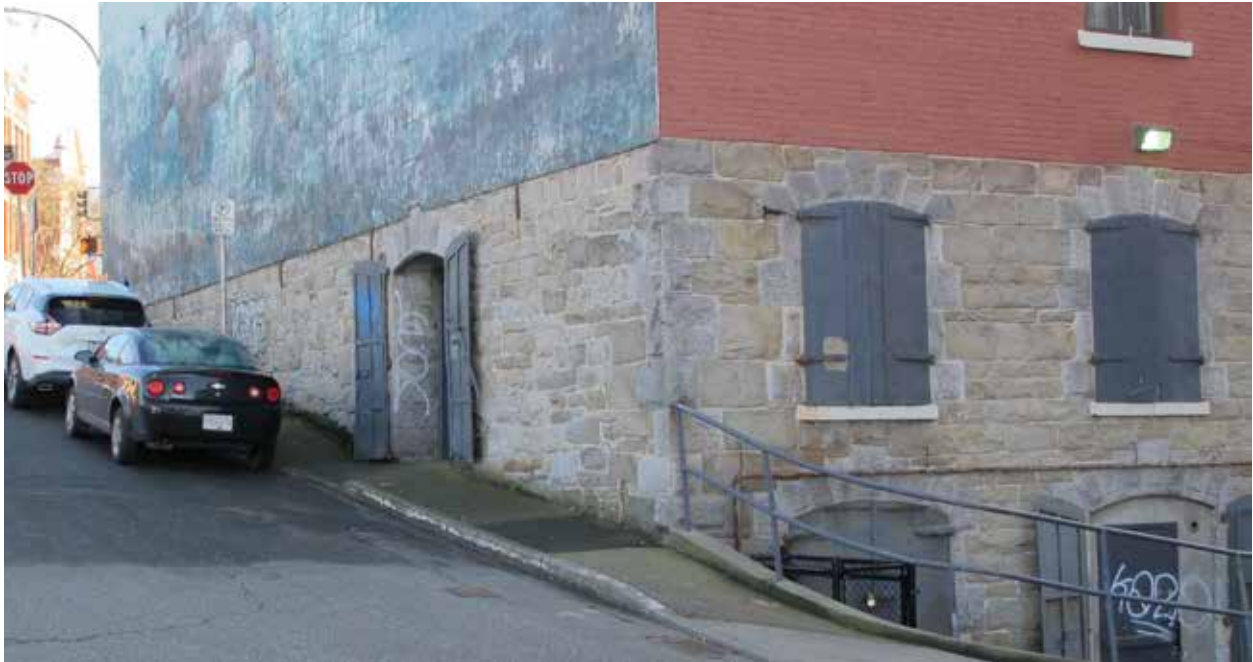
Top: Stone foundation exposed on the north (left) and rear (right) elevations. Stone is laid in a random ashlar pattern on north elevation, and random coursed ashlar on the rear elevation.

Bottom: Rear elevation of the Yates Block with transition (noted with arrow) between original 1882 (left) and 1896 (right) foundations evident.

The Yates Block foundation of the lower harbour warehouse levels, exposed on the side and rear elevations, is constructed in two stages, reflective of the 1882 and 1896 building stages. The north elevation and portion of the rear (west) elevation's foundation is from the 1882 stage of construction and comprised of sandstone with granite elements. The sandstone of the north elevation foundation is laid in a random ashlar pattern while the rear elevation foundation was laid in a random coursed ashlar pattern. Also characterizing the lower levels of the side and rear elevations of the 1882 portion of the block are granite fenestration surrounds and quioning. On the lower levels of the rear elevation the transition between the 1882 foundation and 1896 addition is evident. The foundation of the 1896 addition is limestone with parged fenestration surrounds. Overall, the foundation is intact and appears to be in good condition. There are localized areas of deterioration such as chips to the stone, staining (below exhaust fan), moisture issues resulting in organic deposits (e.g. behind downspouts), rust staining, and localized mortar loss.

The extant stone foundation will be preserved as part of the proposed redevelopment. Seismic improvements may be required as part of the redevelopment. These improvements should not be evident on the exterior of the building. Measures should be taken throughout the project to ensure that no damage occurs to the masonry walls above grade during any interventions throughout the course of the project.

- Existing foundations to be preserved.
- Foundations should be reviewed by a Structural Engineer to determine their condition. Once condition is assessed, conservation recommendations can be provided, if required.
- To ensure the prolonged preservation of the new foundations, all landscaping should be separated from the foundations at grade by a course of gravel or decorative stones, which help prevent splash back and assist drainage. New vegetation may assist in concealing the newly exposed foundations, if desired.

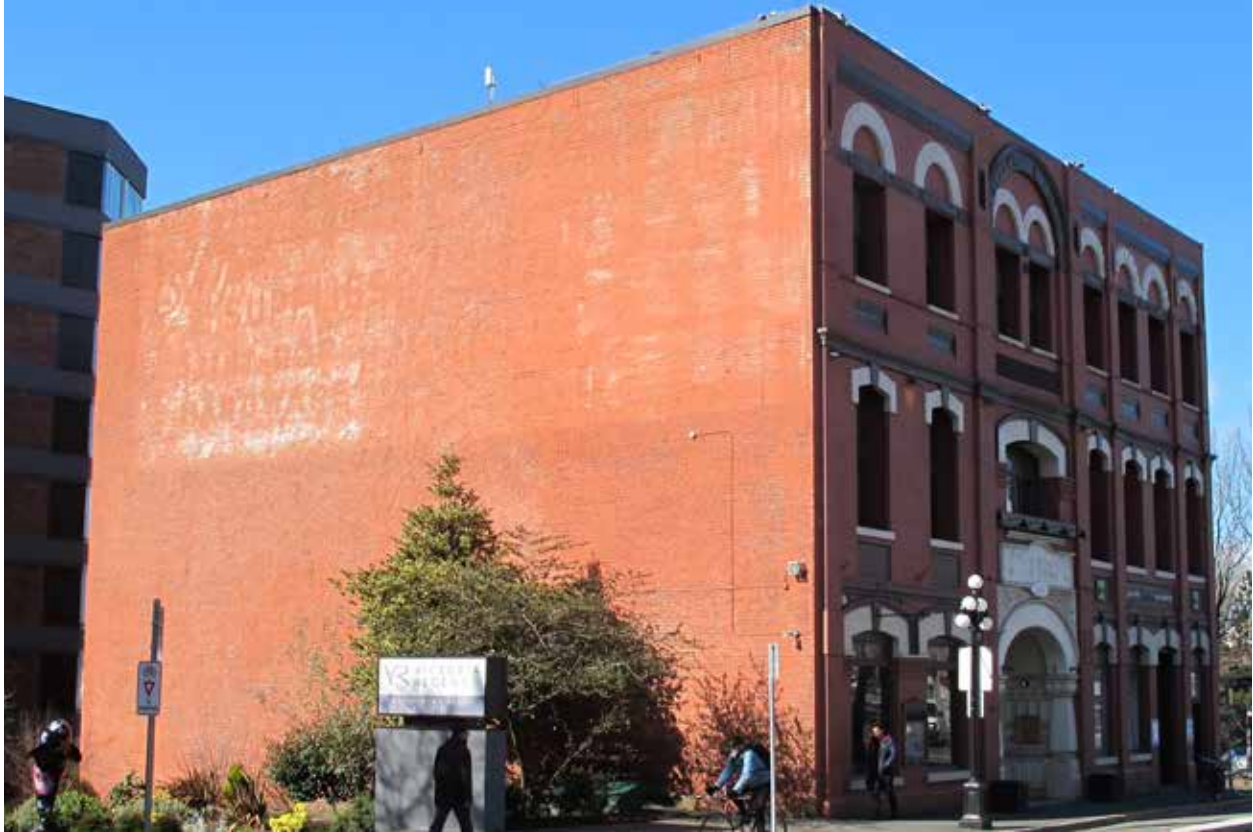
South elevation (left) of the Yates Block with ghost lettering of past painted signage.

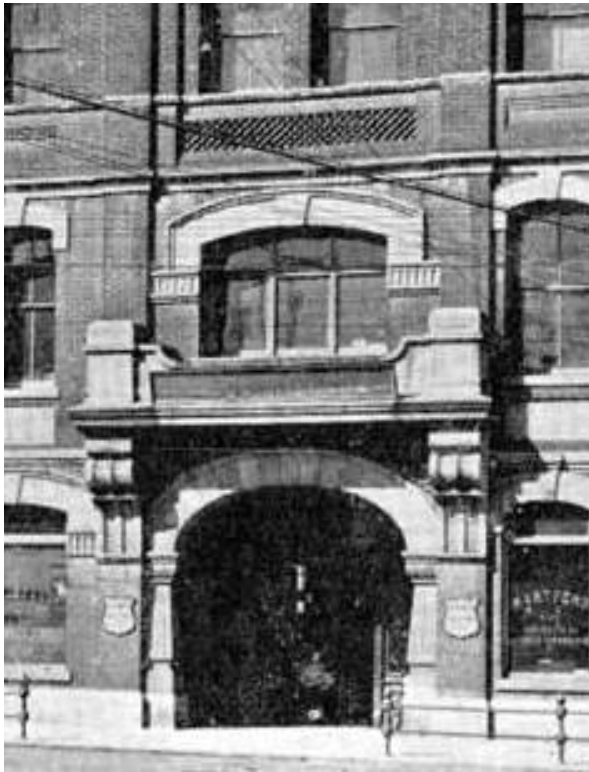
Main entry of the Yates Block following the 1896 addition with balcony supported by large scroll-like brackets.

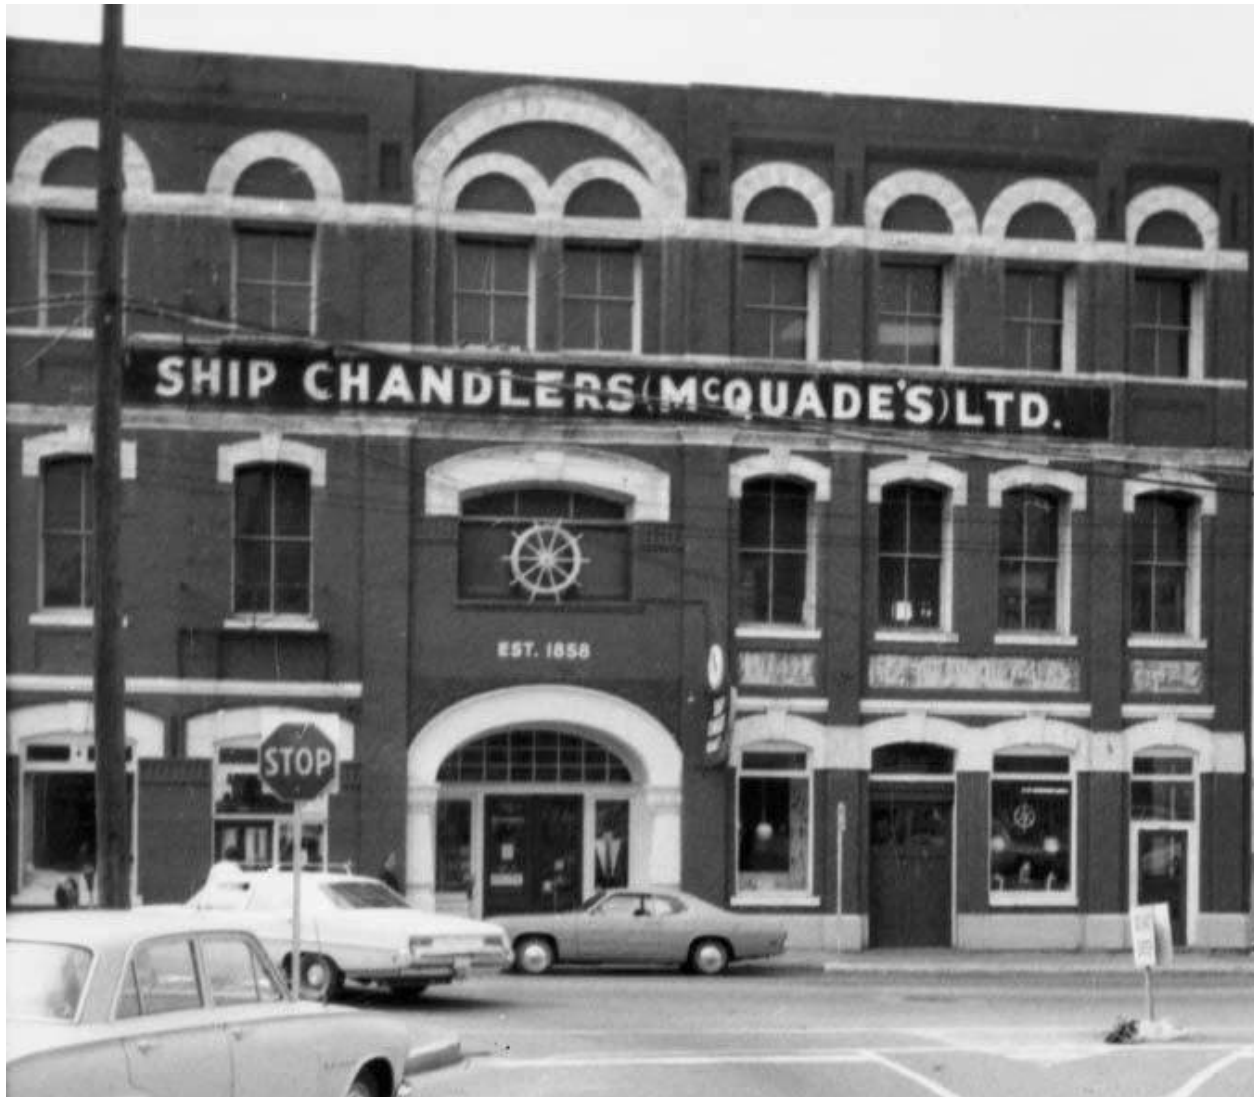
The Yates Block currently has a flat parapet on its south and east elevations and a stepped parapet on its north elevation. The parapet is capped in metal flashing which from street level appears to be in good condition with no gaps, buckling, or corrosion

Yates Block, c.1972, with metal cornice and entry canopy removed and masonry parapet altered.

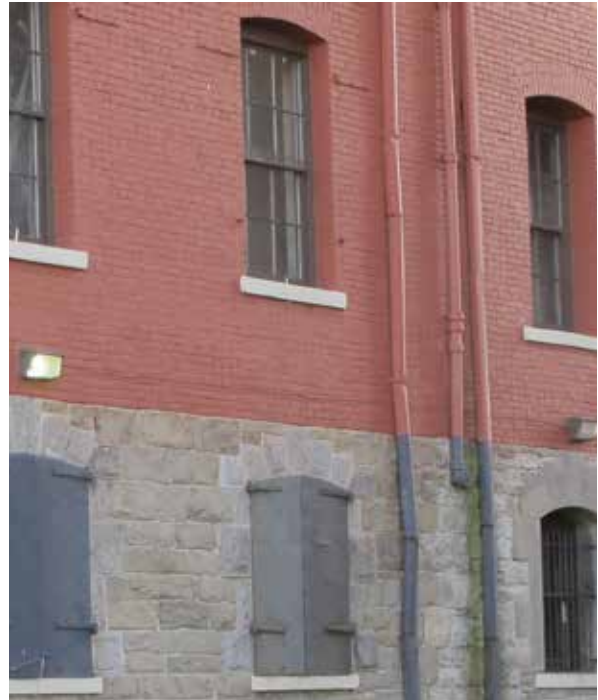
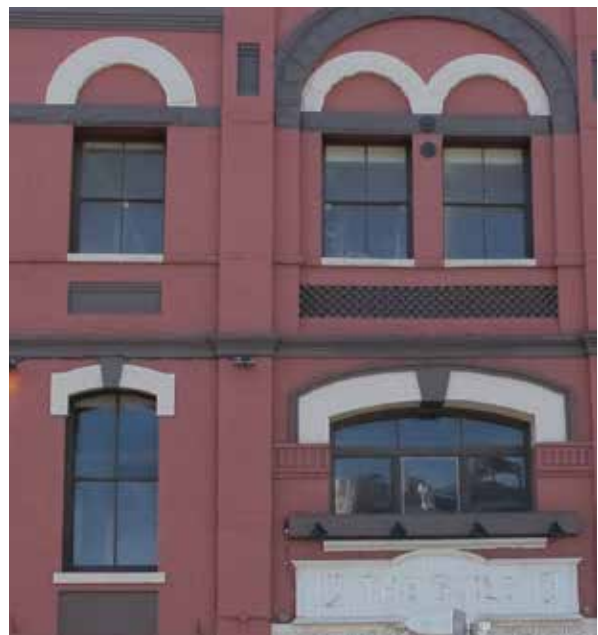
Above: 6-over-6, hung, wood windows on rear elevation. Note fire shutters present at lower level and evidence of past shutters on floor above.

Below: Windows of front elevation including 2-over-2, hung, segmental arch wood windows; 2-over-2, hung, wood windows; and triple assembly wood window with multi-lite segmental arch transom.

windows. The windows of the second floor of the earliest portion of the building also have metal fire shutters. The windows on the rear elevation are six-over-six, hung, wood windows on the upper floors and multi-lite wood windows on the lower warehouse levels. A number of the windows on the rear elevation possess metal fire shutters, while others (upper floors of the 1882 and 1892 portions) have evidence of fire shutters which have since been removed. In addition to the removal of some of the fire shutters on the rear elevation, additional interventions have been made to this elevation such as the replacement of some sashes, repurposing of sashes to accommodate HVAC equipment, and installation of metal grilles in some of the openings.

- Inspect for condition and complete inventory to determine extent of interventions required to existing windows.
- Retain existing window openings, metal fire shutters, and any intact original wood windows, where feasible.
- Preserve and repair windows as required, using in-kind repair techniques as needed.

- Install new wood frames and sashes where frames and sashes are missing or beyond repair. New elements to match existing originals.
- Create new window openings on north, west, and south elevations, and restore existing window openings on north elevation and previously altered openings on west elevation to suit new interior use. New wood window assemblies to be installed, where possible.
- Prime and repaint as required in appropriate colour, based on colour schedule devised in consultation with Heritage Consultant.

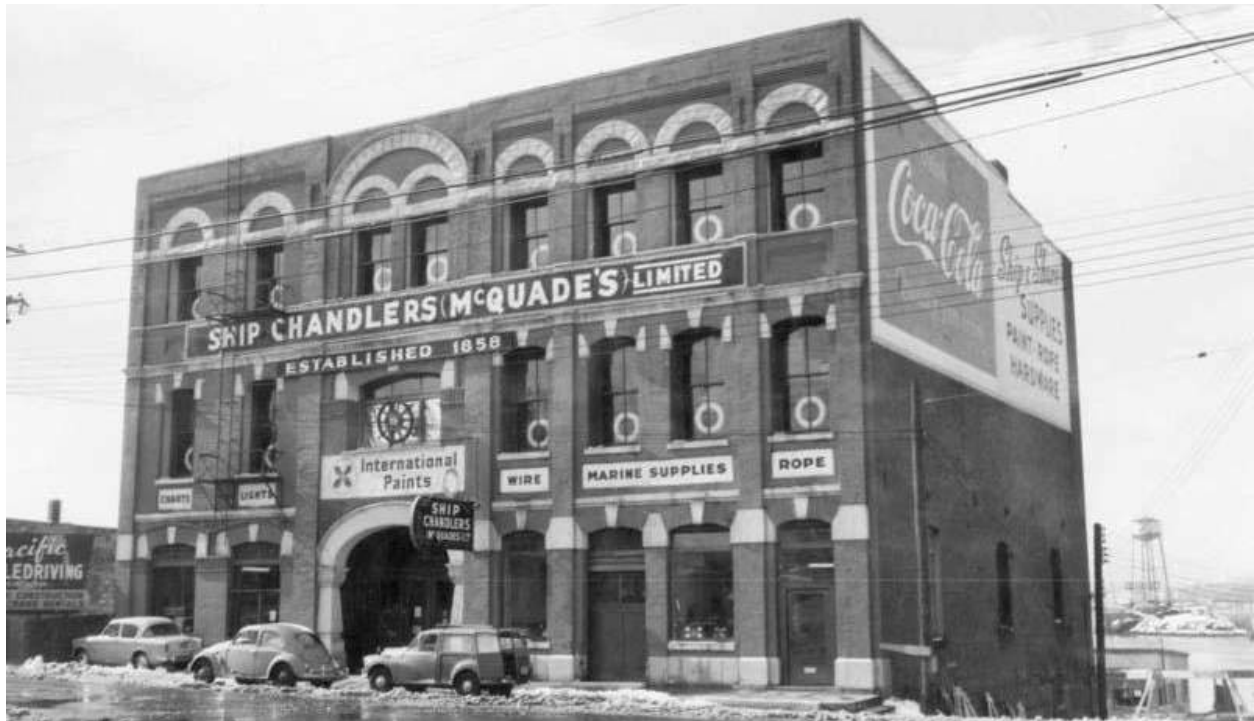
The Yates Block as it appeared in the 1960s with north elevation windows evident. (City of Victoria Archives M01147)

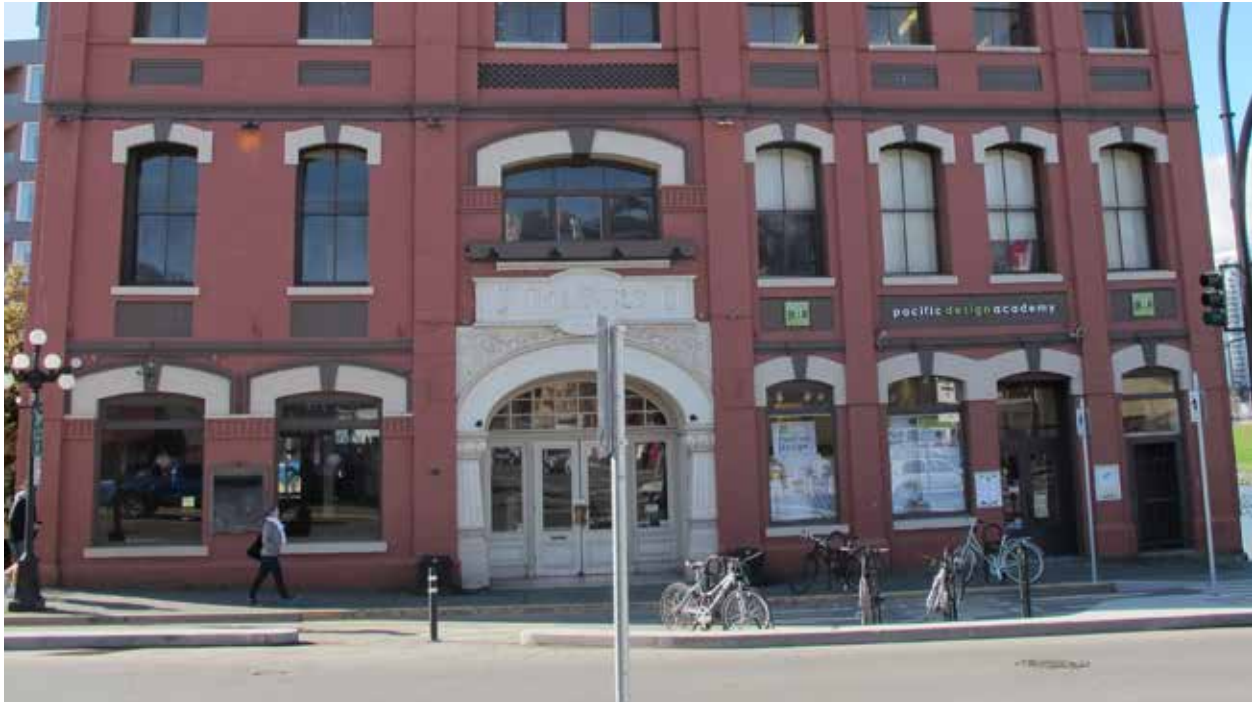
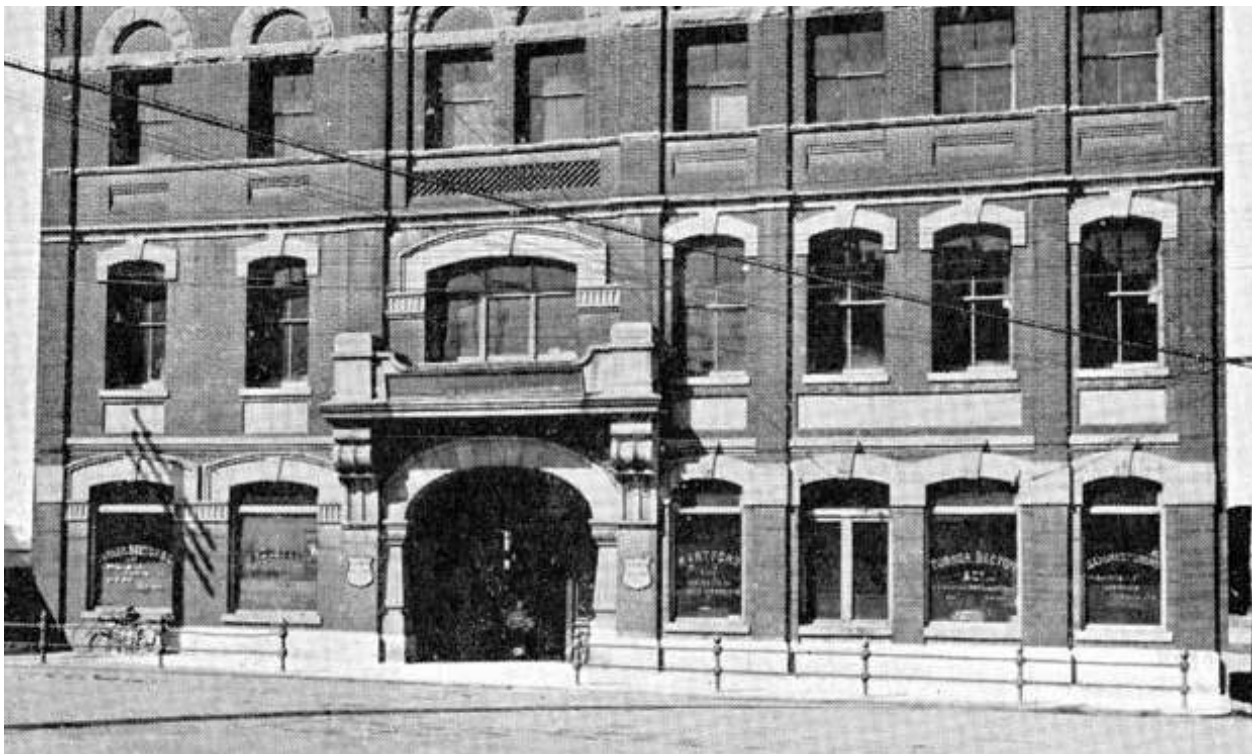
Above: Contemporary view of the Yates Block storefront with off-centre main entry and two secondary entries.

Below: Yates Blocks storefront after completion of 1896 addition with only off-centre main entry present.

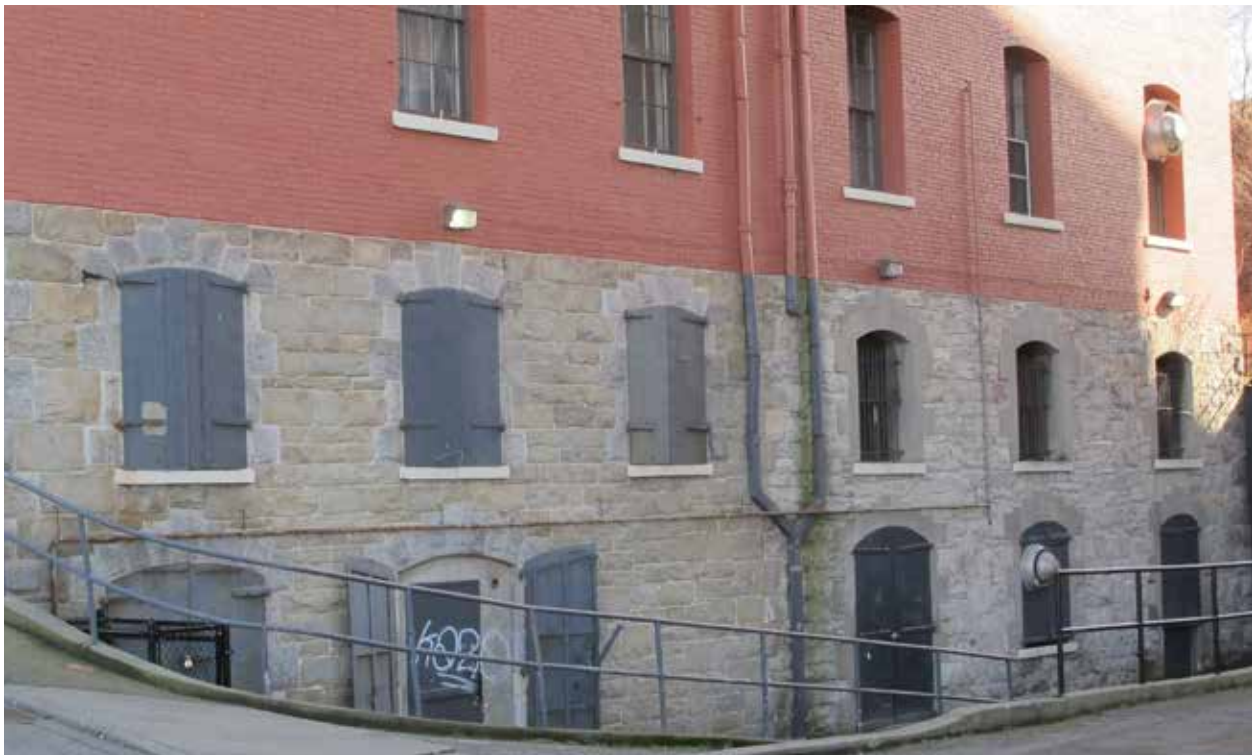
Rear elevation of the Yates Block with four doors providing access to the building's lowest level.

- Retain the recessed door openings of the north and west elevations in their original locations.
- If possible, preserve and repair any original door assemblies.
- Rehabilitate the north elevation entry to suit the new interior use of the building.
- Install new entry on south elevation.
- Where any new doors are installed, they should be visually and materially compatible with the historic character of the building.
- Finish doors based on finish schedule devised in consultation with Heritage Consultant.

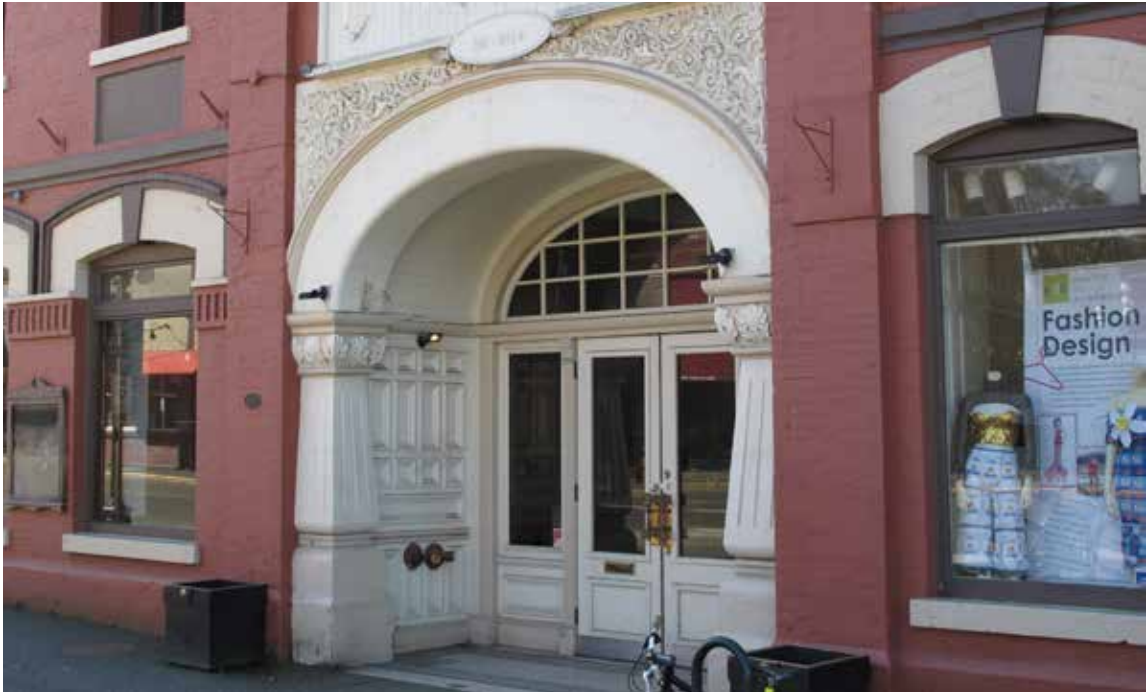
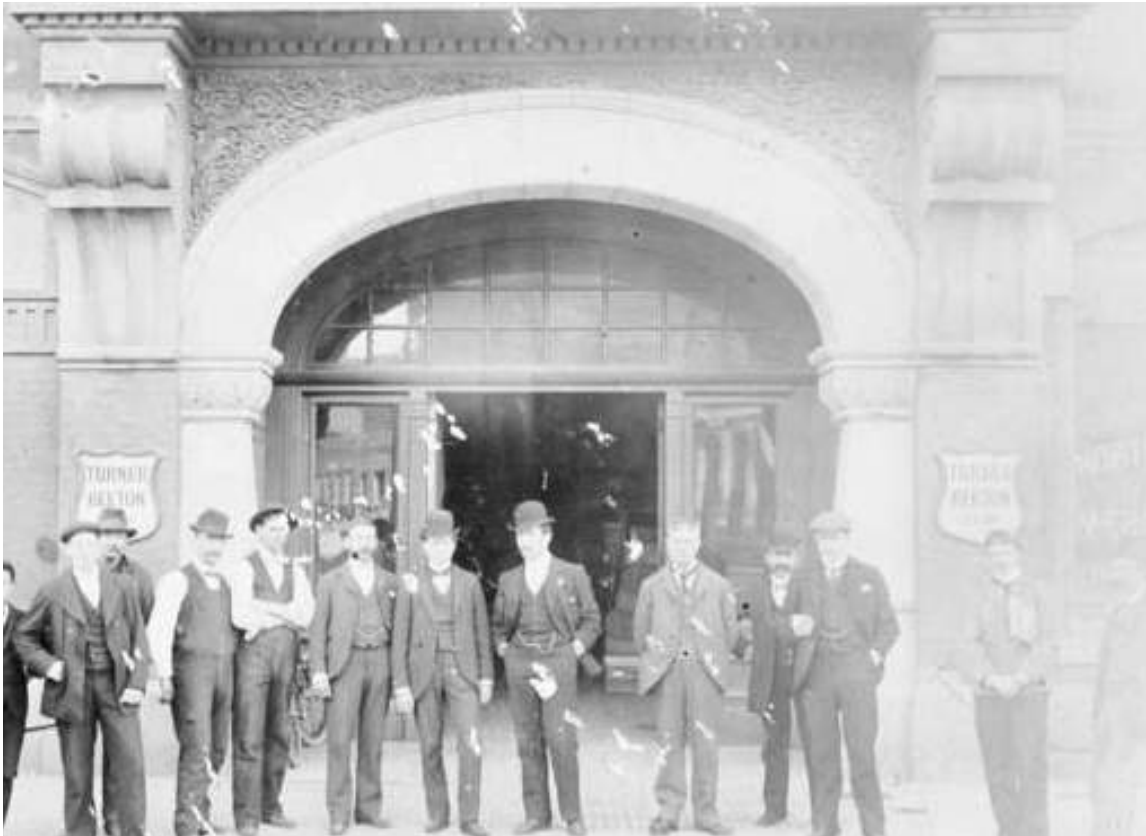
Top: Current main entry of the Yates Block.

Bottom: Detail of the main entry of the Yates Block following completion of 1896 addition with decorative balcony over the main entry in place.

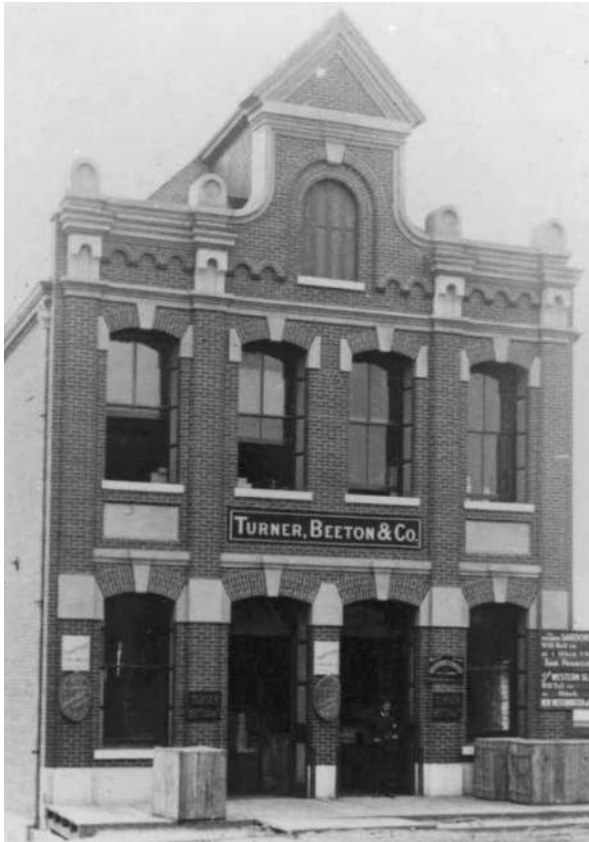
Yates Block with two entries in central bays, flanked by single windows in each structural bays
