## Heritage Advisory Panel Report For the Meeting of June 11, 2024

**To:** Heritage Advisory Panel **Date:** June 7th, 2024  
**From:** Kristal Stevenot, Senior Heritage Planner, Development Services  
**Subject:** Heritage Designation Application No. 000209 for 1885 Government

# SAM KEE LAUNDRY

1885 GOVERNMENT STREET, VICTORIA, BC

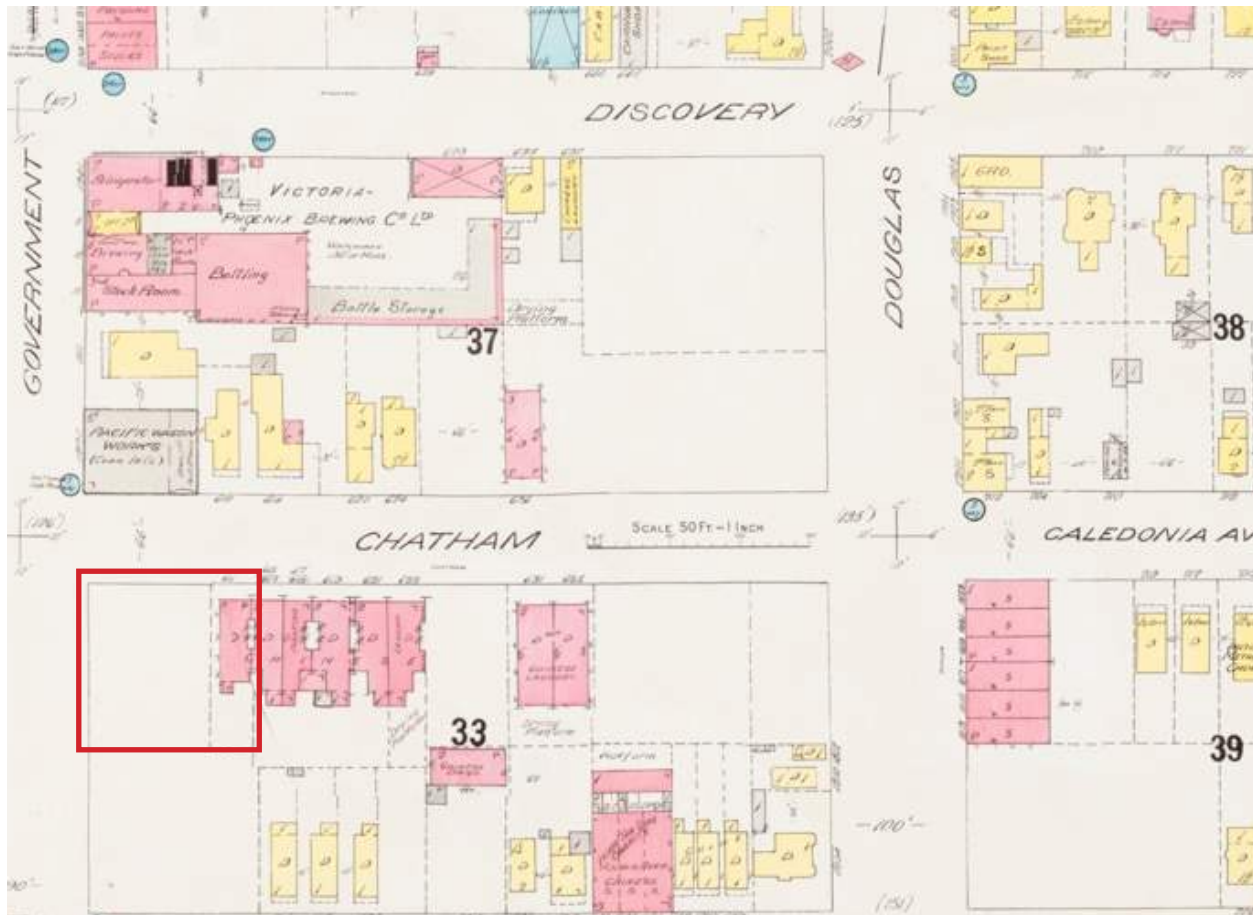
Above: Project site, 1911 (rev. 1913). Vol. 1 of Insurance Plan of Victoria, BC. Chas. E. Goad, Sheet 015 [University of Victoria]

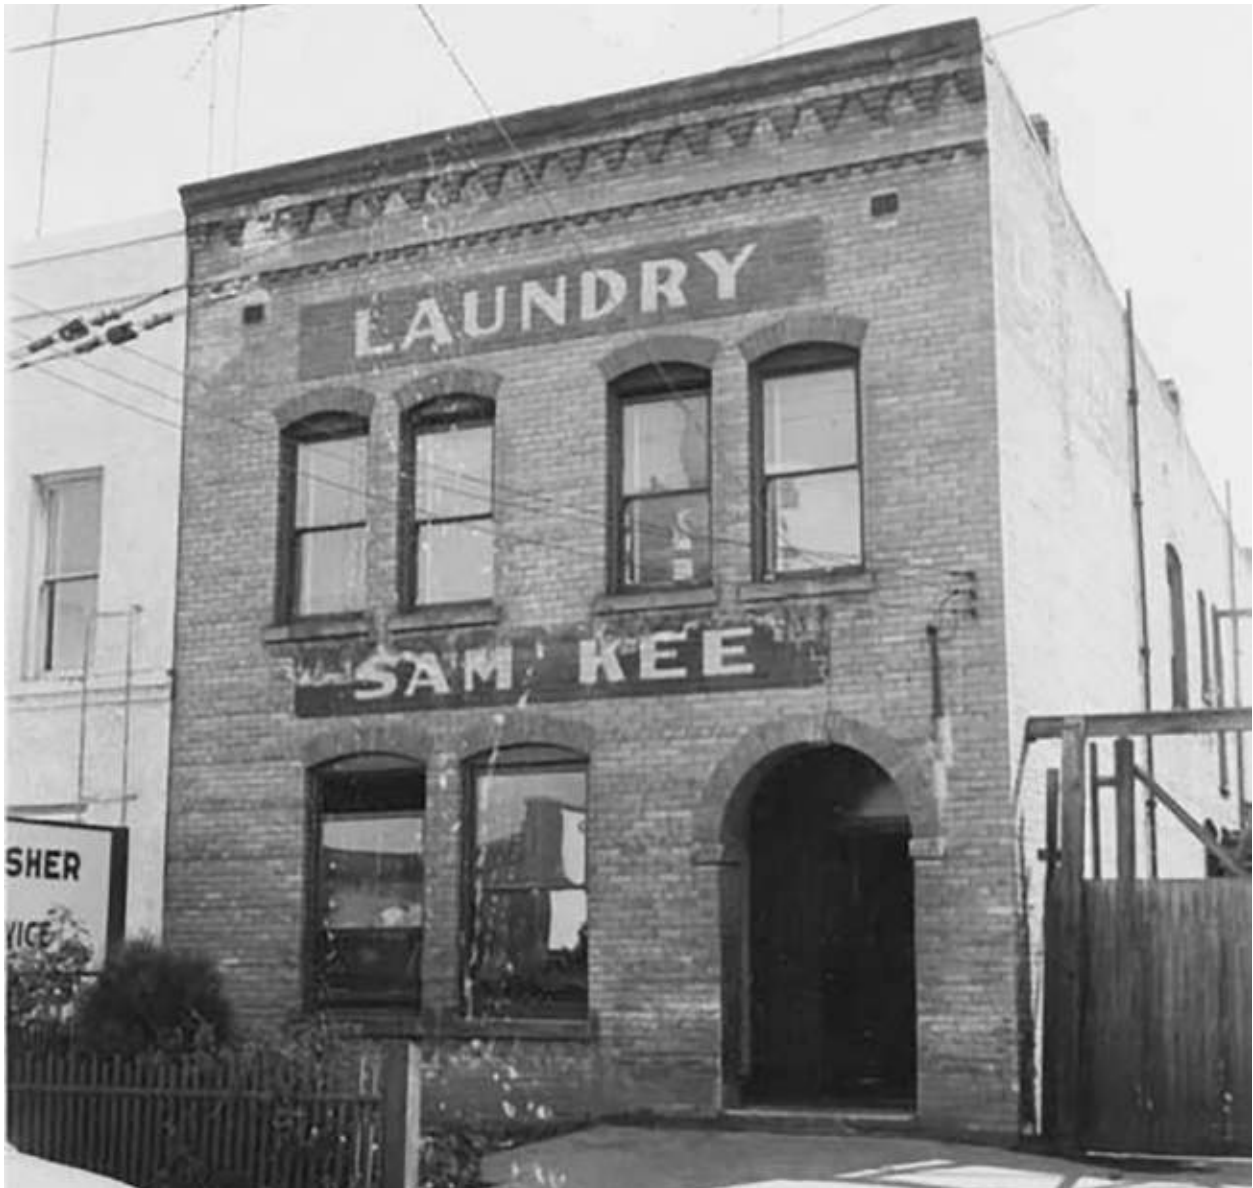
Above: Sam Kee Laundry (611 Chatham Street), 1959. [City of Victoria Archives CoV-CR-0170-M01204]

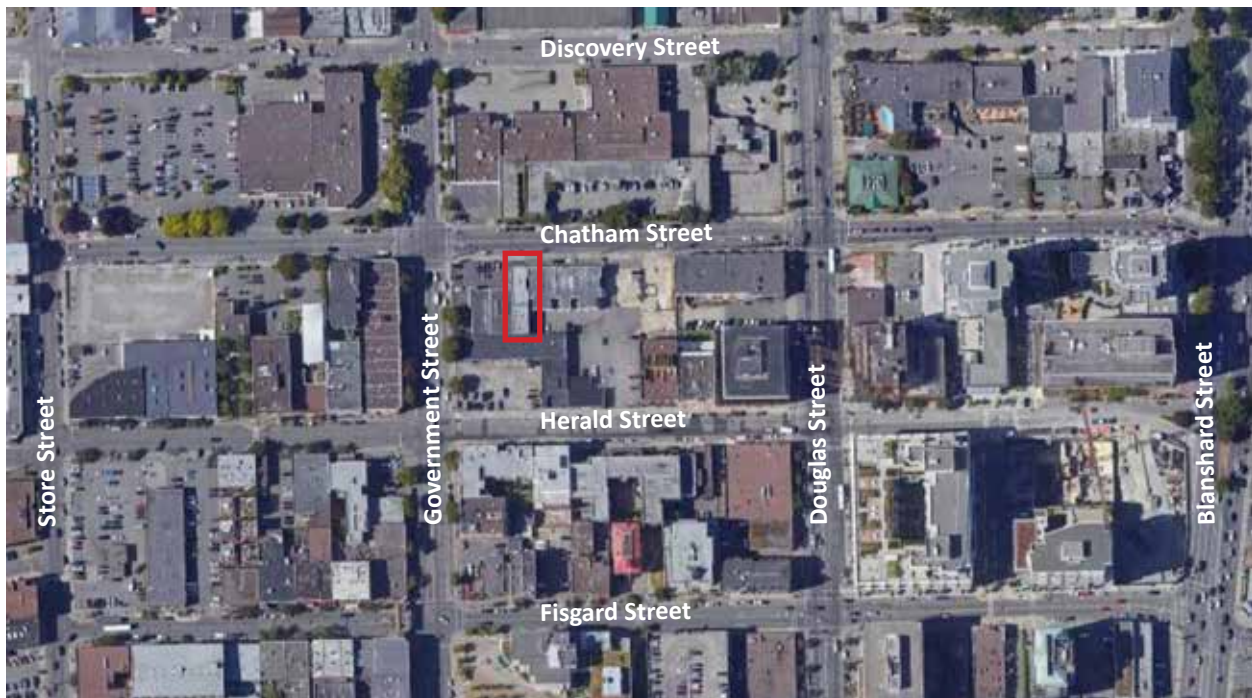
Above: Sam Kee Laundry building (outlined in red), 2023 (Google). The July 1907 fire destroyed the blocks from Store Street to Blanshard Street and from Chatham Street to Herald Street.

The extant two-storey masonry building replaced an earlier two-storey wood-frame building that was destroyed by a fire. On July 23, 1907, a fire broke out at the Albion Iron Works which destroyed buildings from Store Street to Blanshard Street and from Chatham Street to Herald Street. The Sam Kee Laundry was one of the first buildings constructed after the fire. The extant building was at one time part of a collection of historic residential buildings built on the south side of Chatham Street following the fire; however, now, only the Sam Kee Laundry building remains.

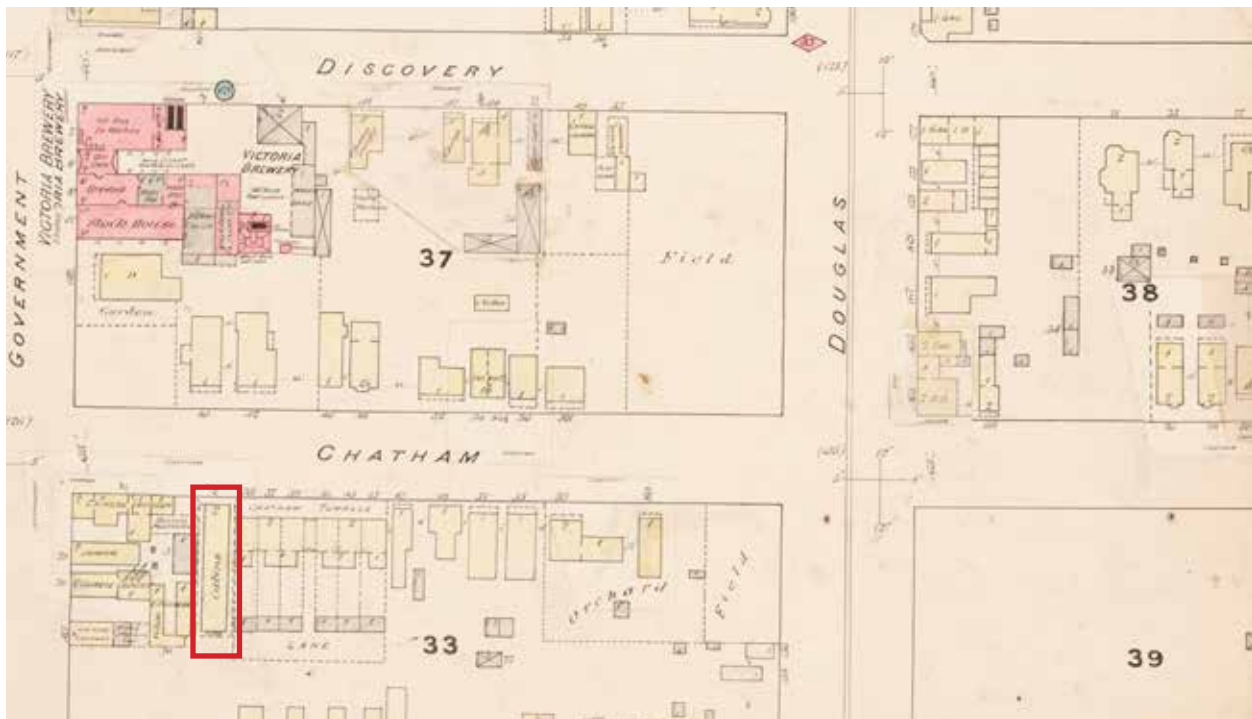
Above: Future location of the Sam Kee Laundry building, 1887. (Insurance Plan of Victoria, BC. Swan, Fudger and Co., Sheet 04 [LAC])  
 Below: Two-storey wood building destroyed by fire in 1907 (red box) where Sam Kee Laundry building was constructed, 1891 (rev. 1895). (Insurance Plan of] Victoria, BC. Chas. E. Goad, Sheet 15 [UVic])

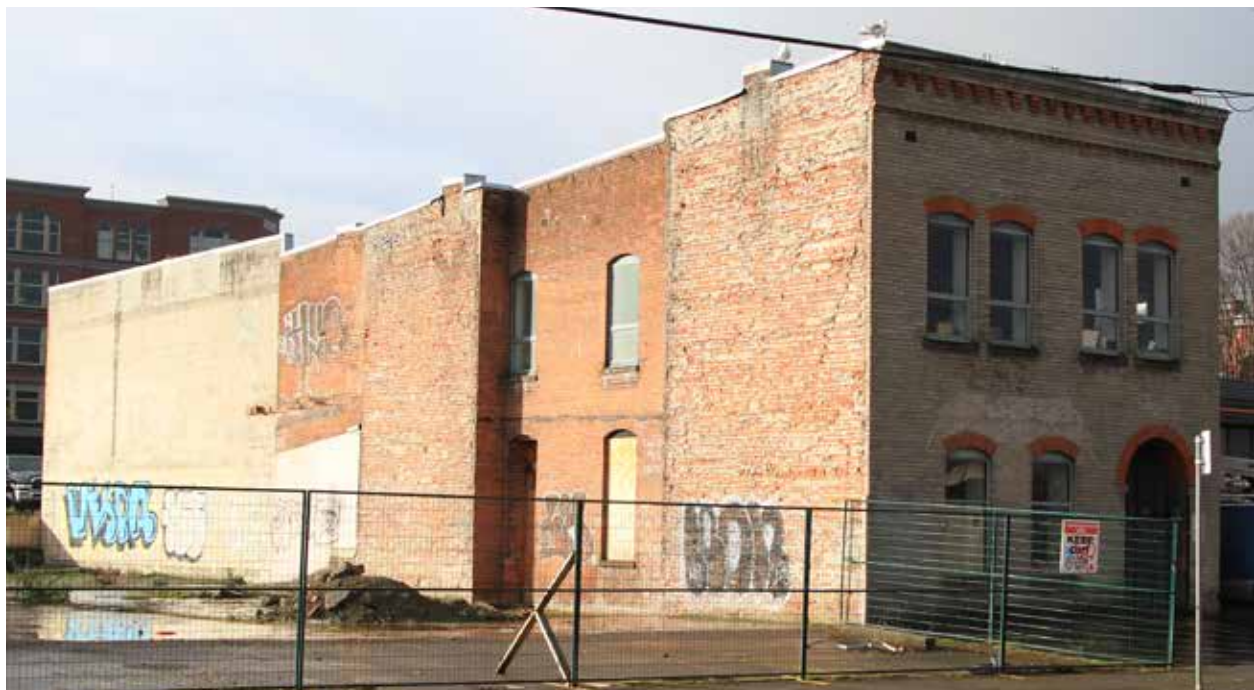
Above: Sam Kee Laundry building, 2023. Note light well on east elevation and addition on rear of building.

The form, scale, and massing of the Sam Kee Laundry building remains largely intact from the time of its construction in 1908; however, later additions have been constructed at the rear and side of the building. When the two-storey, rectangular plan building was first constructed, it consisted of 11 rooms between its ground and upper storey, with a recessed lightwell on its east elevation. The building was built with a modest parapet and cornice, off-centre recessed entry with windows present on all of its elevations. The building’s residential use remained until 1936 when the Sam Kee Laundry, previously located at 637 Discovery Street, moved into the building following renovations. By 1947, a wood drying platform had been added to the

rear of the lot. Since that time, numerous alterations to the historic building have occurred including: interior alterations converting the first floor to offices with two apartments on the second floor in 1967; a two-storey concrete block addition added to the rear of the building prior to 2001; and, alterations to the second floor layout and finishes, conversion of the first floor windows to a bay window, as well as replacement of window and door assemblies all at unknown dates. The bay window has since been removed and two single assembly windows installed; however, their placement and dimensions do not match the original windows at this location.

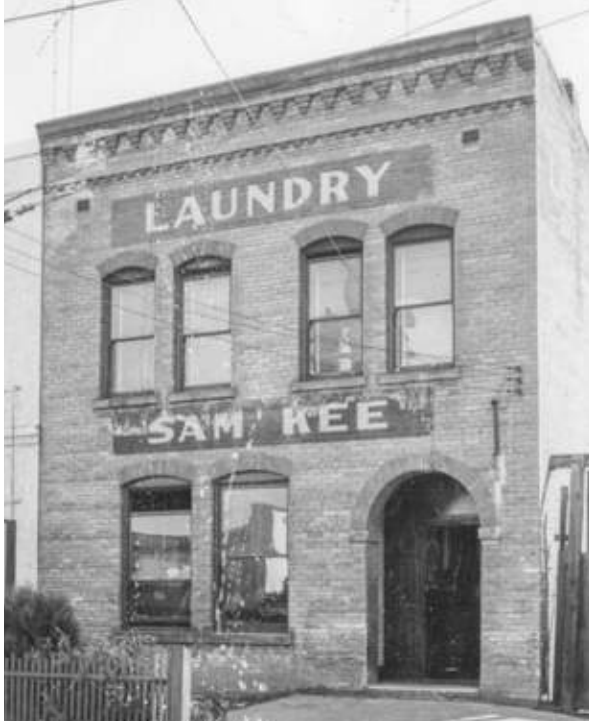
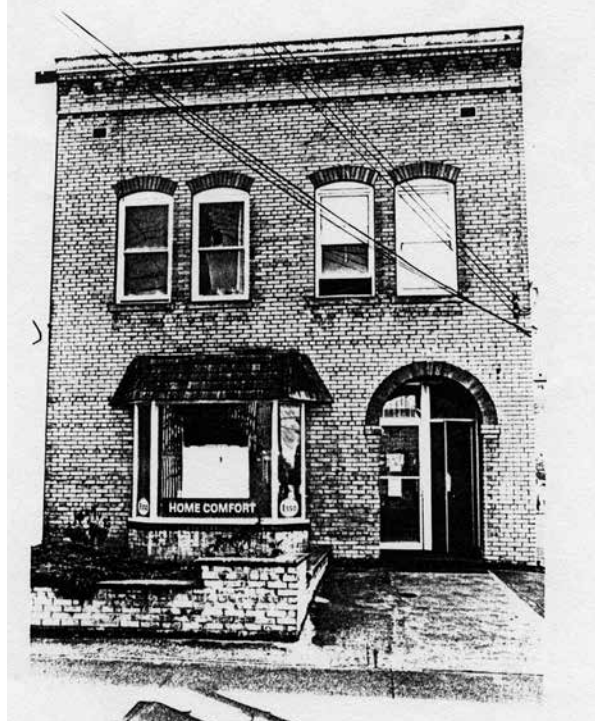
*Above Left: Sam Kee Laundry building, 1959 prior to any alterations to its exterior with its double-hung wood assembly windows intact. Above Right: Sam Kee Laundry building, after alterations to its first floor such as the installation of a bay window and aluminum doors. Below Left: Sam Kee Laundry building today, 2023 with single assembly windows restored to the first floor and all other original wood windows replaced.*

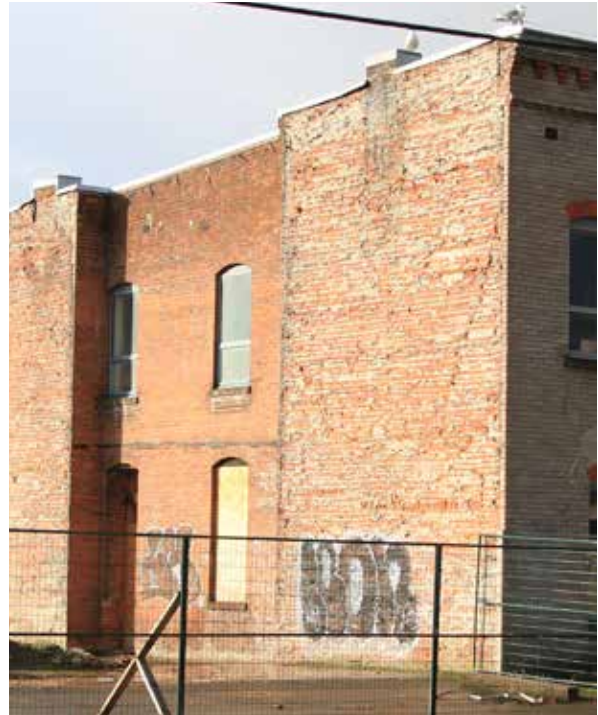
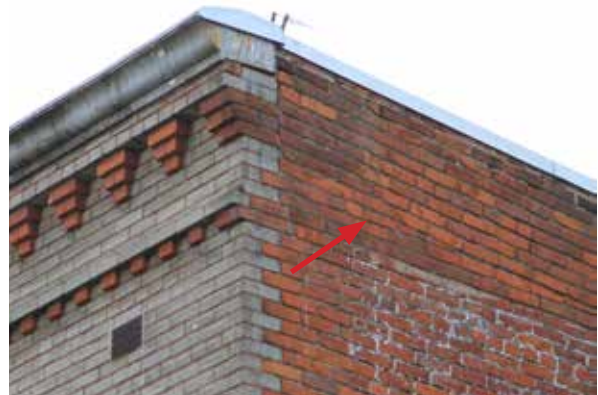
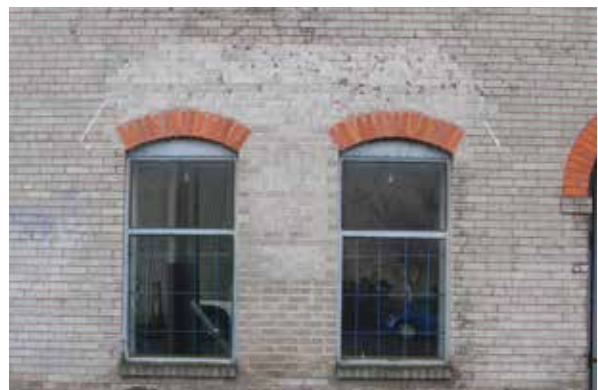
The two-storey load-bearing masonry building is constructed with multi-wythe red brick walls with grey mortar. The Sam Kee Laundry's front elevation is finished with a distinct grey brick with red mortar. The front elevation is further accented by the use of red brick at its parapet and lintels. The masonry walls were laid in common bond with the parapet of the side elevations sloped to the south. To achieve the sloped side parapets, courses of brick were cut and tapered and are evident on the side elevations. When the Sam Kee Laundry was constructed, a building had already been built to the east of the extant building. The presence of the neighbouring building, which has been torn down, accounts for the unfinished state of sections of the east elevation.

Overall, the building's brick exterior walls are largely intact from the time of its construction; however, there have been past interventions and areas of localized deterioration is present. Later additions to the west and south elevations obscure the condition of the brick in these areas. A significant intervention to the front elevation of the Sam Kee Laundry is evident at the first floor where the original single assembly windows were replaced with a single bay window. Single assembly windows at the ground floor were later reintroduced; however, their placement and dimensions do not match the original windows at this location. An attempt was made to match the original grey brick to fill in the larger opening left from the original windows, and subsequent bay window; however, the brick used does not have a similar texture and features a lighter colour than the original. The mortar used is also a poor match to the original red mortar of the front elevation.

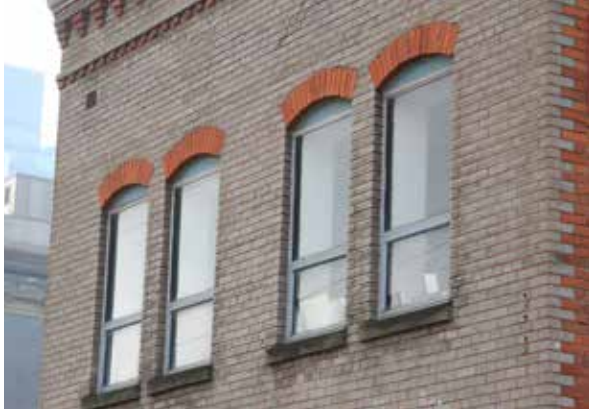
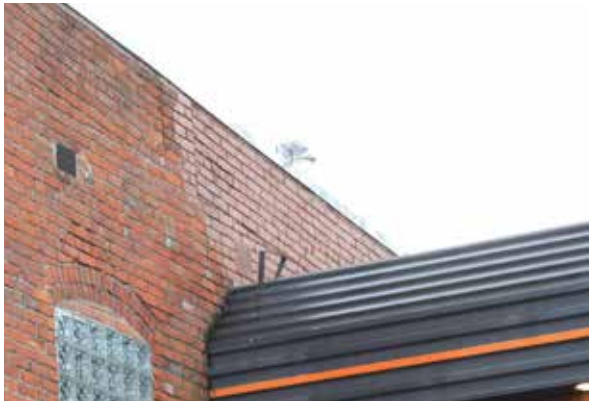
*Left Top: Unfinished brick and finished brick of light well of east elevation.*

*Left Middle: Grey brick with red mortar on the front façade and red brick with grey mortar on the side elevation. Coursing of tapered brick shown (red arrow).*

- Preserve the brick of the front and side walls and replace in-kind brickwork that is too deteriorated for safe retention.
- Undertake complete condition survey of condition of all brick surfaces. Retain sound exterior masonry or deteriorated exterior masonry that can be repaired using Jahn repair mortars or approved equivalents.
- Deconstruct rear elevation wall and salvage brick, and if in good condition, for reuse in repairs to interior and side elevations.
- Restore non-original grey bricks along ground storey on the front elevation, between and above the single assembly windows, to match the characteristics of the original grey bricks using available archival records and on-site evidence. Use brick (either salvaged or new) that

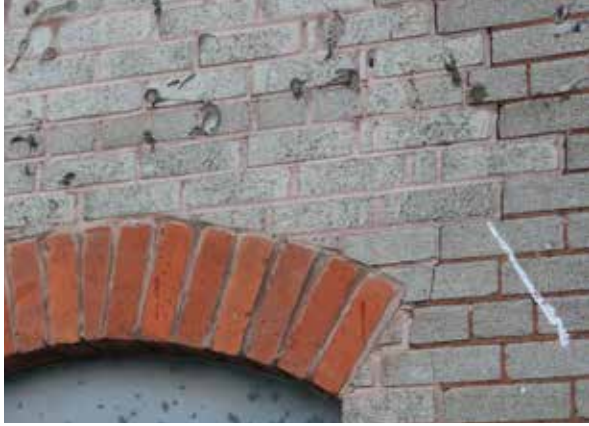
*Top: Previously restored area of first floor front façade. Note crack in brick, difference in mortar and brick between original and restored section, and epoxy residue on brick.*

- Cleaning, repair and repointing specifications to be reviewed by Heritage Consultant.
- Any holes in the brick should be filled or brick replaced to match existing.

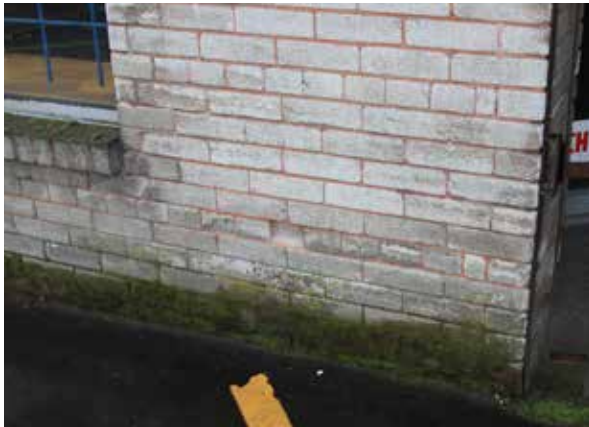
*Middle: Bottom of front façade with significant organic growth and spalled brick. Organic growth due to repetitive wetting.*

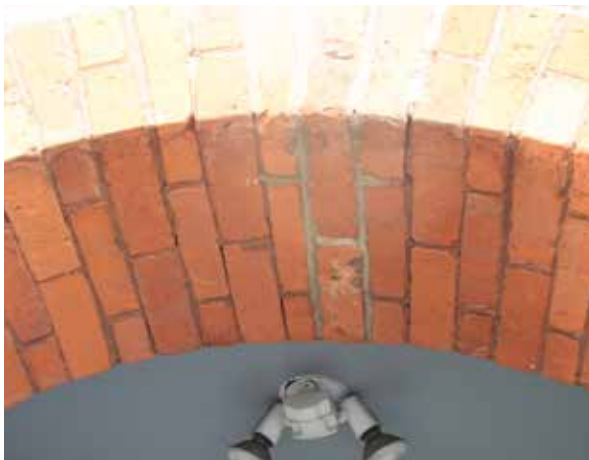
*Bottom: Localized repointing using unsympathetic mortar and brickwork with missing mortar.*

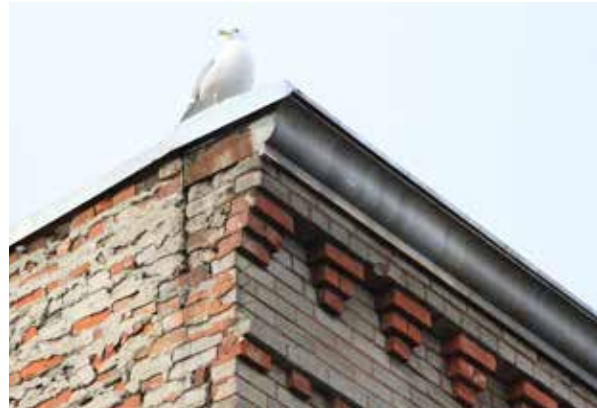
*Above: Original metal cornice of front facade and later added cap flashing.*

A metal cap flashing is present on the side elevations and parapet cornice. The flashing is not original, but may have replaced an earlier cap flashing. As part of the redevelopment, the roof will be rehabilitated. It is anticipated that through the roof's rehabilitation, the cap flashing will also be replaced, if its condition is too deteriorated to retain.

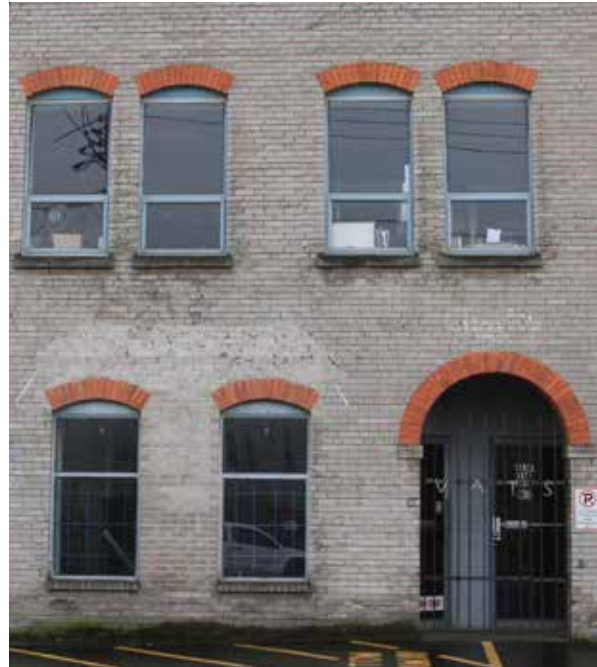
*Above: Fenestration of front elevation with replacement window and door assemblies. Original openings, sills, and lintels remain intact, with exception of ground floor windows.*

When first constructed, the Sam Kee Laundry building possessed windows on all of its elevations and floors, and included a lightwell located on its east elevation. Over time, some of the windows have been altered through later additions, changing window configuration, and replacement of original wood window assemblies. The segmental arch window openings are original and remain intact. Original concrete sills (front elevation), brick sills (side elevations), and brick segmental arch lintels are also intact. Based on archival photographs, the original windows of the historic building were one-over-one, double hung wood windows with integral sash horns. All original wood window assemblies have been replaced. A significant past intervention to the building's fenestration was the replacement of the front elevation's ground floor windows. The original single assembly windows were replaced with a bay window, though the bay window would later be removed and the presence of two single-assembly windows reintroduced; although, their placement and dimensions differ from the original windows at this location.

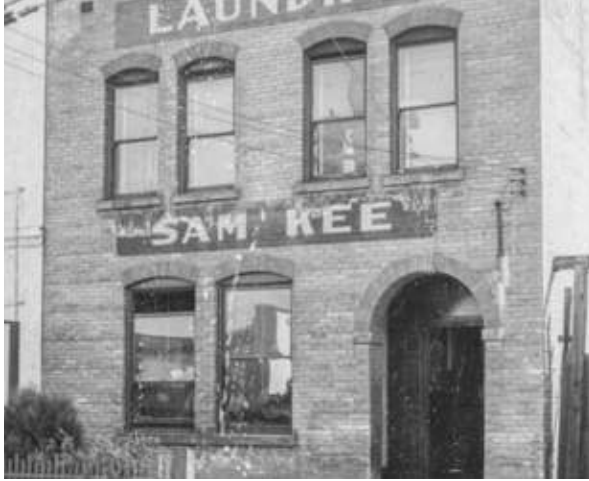
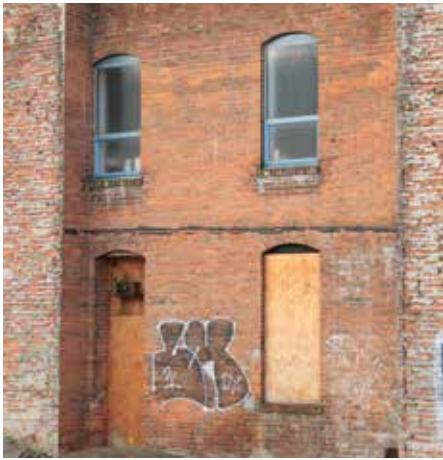
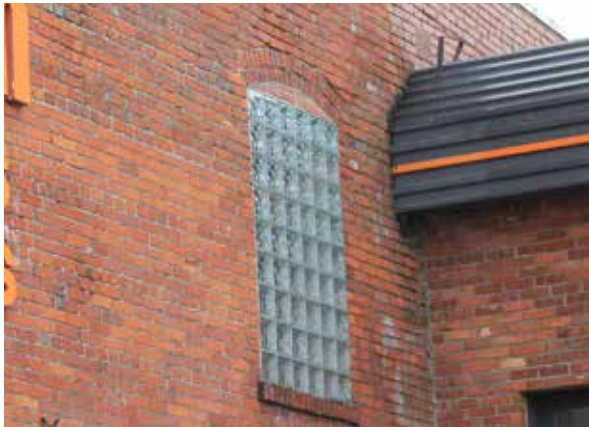
*Top: Original configuration and assemblies of front facade.  
Middle: East elevation with openings, sills, and lintels intact and replacement insert windows.  
Bottom: West elevation with original window opening filled in with glass block.*

Through the proposed redevelopment scheme the fenestration conservation strategy consists of: retention of intact original segmental arch window openings of the retained elevations and associated masonry; conservation of the window openings of the front elevation's ground floor; restoration of wood assembly windows using archival photographs as a guide; possible rehabilitation of glazing in new wood window assemblies to provide improved performance; and, the infilling of fenestration within the lightwell of the east elevation, while preserving the brick surround, sills, and lintels of these openings. These interventions to the lightwell fenestration will be designed in a way to be reversible, and the openings will require to remain interpretable as former windows from within the interior.
