**EXECUTIVE SUMMARY**  
**Citywide Seismic Vulnerability Assessment of**  
**The City of Victoria**

**Prepared for:**  
**The Corporation of the City of Victoria**  
Victoria, British Columbia, Canada

**Prepared by:**  
**VC STRUCTURAL DYNAMICS LTD.**  
Vancouver, British Columbia, Canada  
**November 22<sup>nd</sup>, 2016**  
Vancouver, Canada

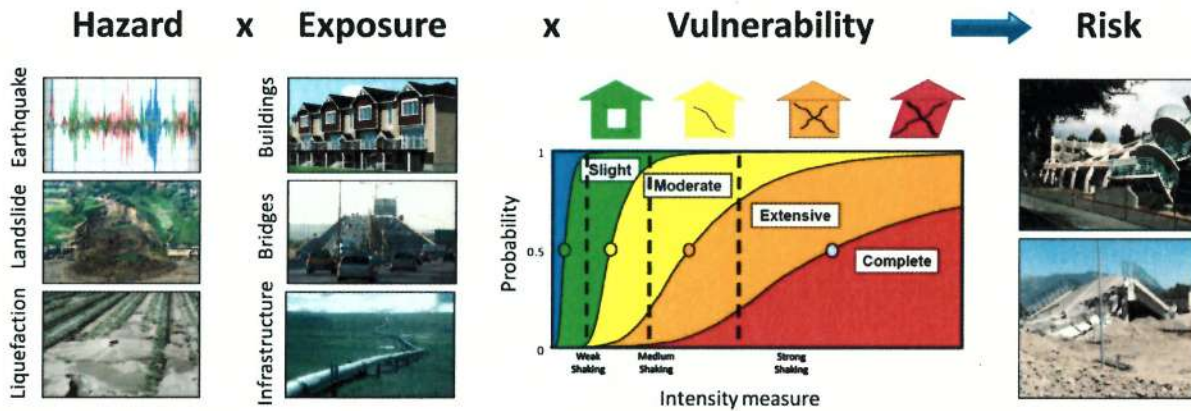
**Figure 1: Relevant Factors Contributing to Risk**

The degree of risk (potential losses) depends, not only on the level of hazard, but also on the elements exposed to the hazard, including their value and their vulnerability to the type of hazard (Figure 1). The level of risk is increased when a higher concentration of assets is exposed to the hazard. Accordingly, risk analysis and management must include consideration of all relevant factors contributing to the level of risk including the hazard, exposure, and building and infrastructure vulnerability. An explanation of each factor and their relevant impact to seismic risk assessment of City of Victoria is presented in the following sections.

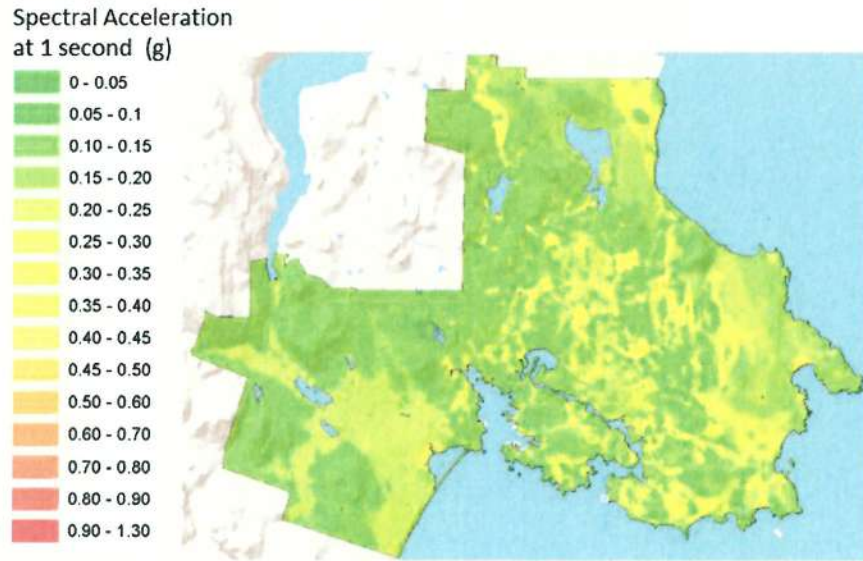
**Figure 7: Ground Motion Intensity (1 Second Spectral Acceleration) Expected from the M = 7 Inslab Earthquake Scenario**

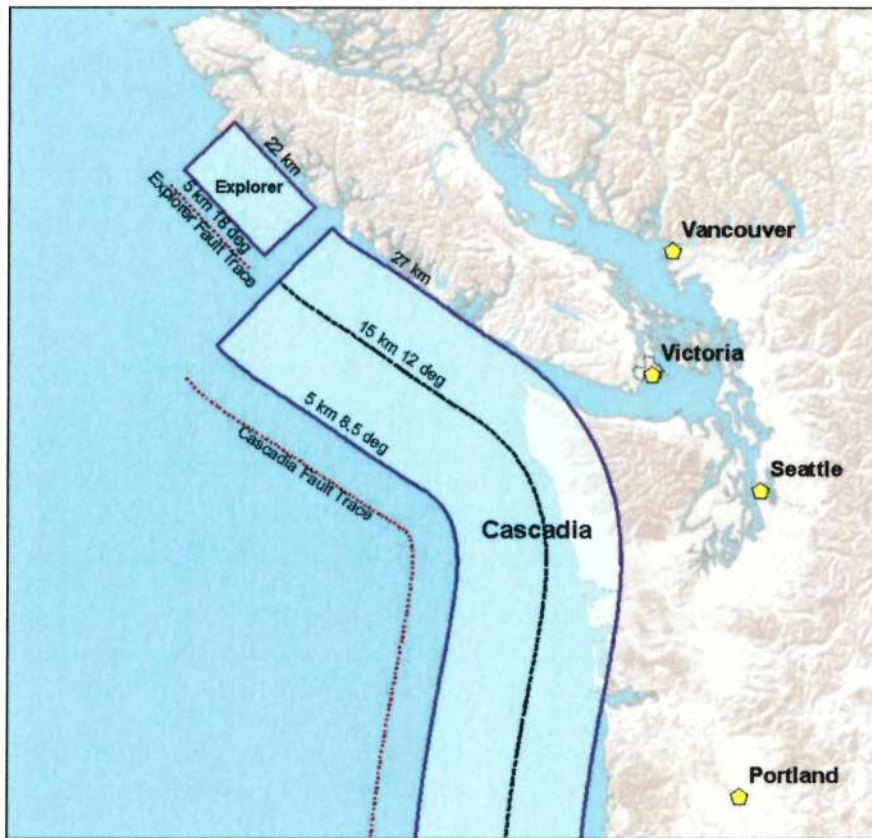
Figure 8: Cascadia Subduction Zone Including the Fault Surface Traces, Fault Depths and Dips, and Best Estimate of Landward Rupture Extent (data from Halchuk et al., 2014)

A full rupture of the Cascadia Subduction Zone (CSZ) would be about 1025km long and 125km wide and could slip 25m (Adams and Rogers, 2012). This could generate an earthquake of magnitude 9 or greater. An important factor in this event would be how far it occurs from Victoria. We assumed that the rupture limit of this event would be constrained by the 450 degree isotherm, after which temperatures are too high for a significant rupture to occur as the plates begin to melt (Adams and Rogers, 2012). Figure 8 illustrates the proximity of the City of Victoria to the predicted rupture area. The best estimate of the 450 degree isotherm is the 27km deep contour in this figure. Figure 9 presents the shaking intensity predicted from this event.

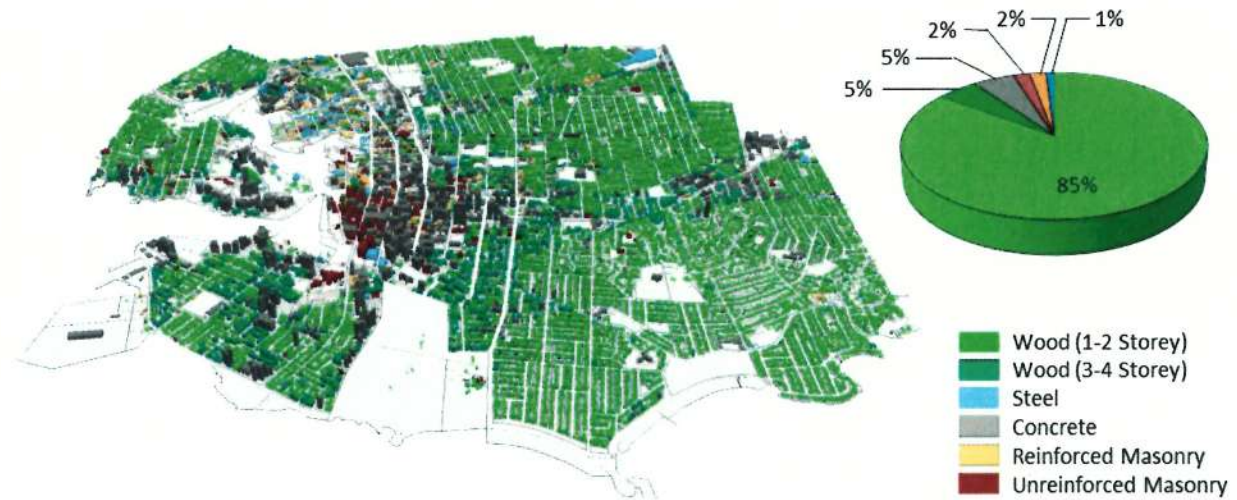
Figure 12: Distribution of City of Victoria Buildings Based on Construction Type

From the previous figures: Figure 22 (risk), Figure 11 (soil hazard), Figure 12 (construction type), and Figure 13 (year built); several trends can be observed as summarized in Table 6.

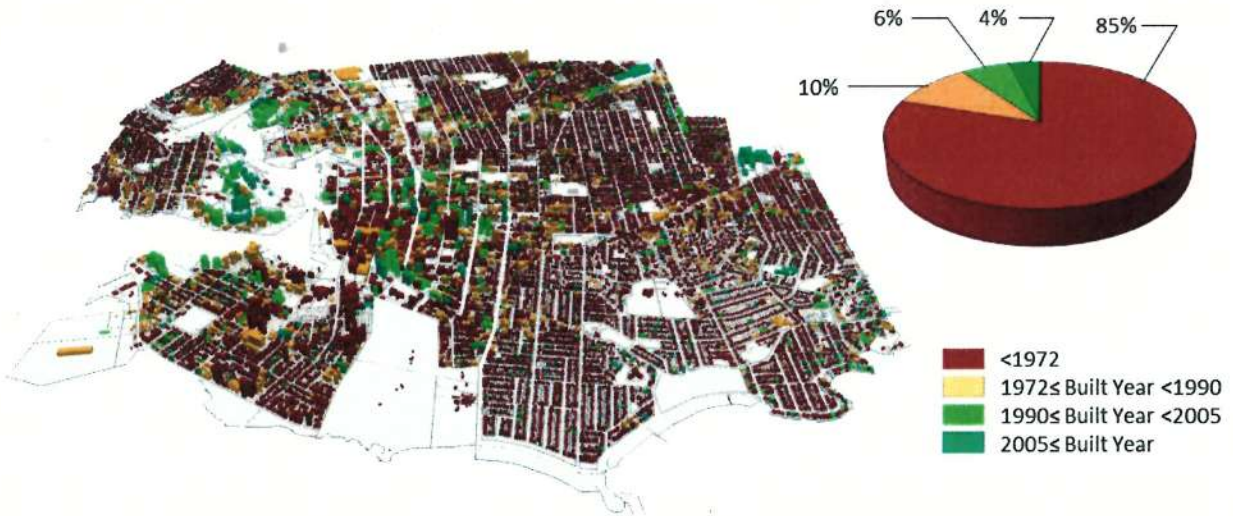
Figure 13: Distribution of City of Victoria Buildings Based on Year Built

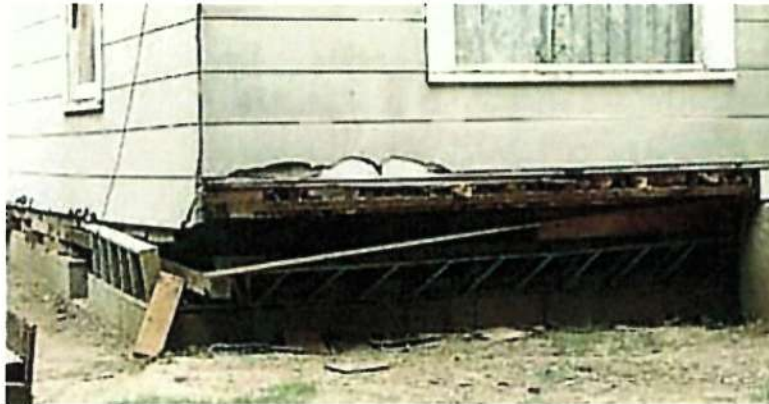
Figure 15: Cripple Wall Failure Due to an Earthquake (homerepair.com)

An example of a cripple wall failure in a light wood frame structure is presented in Figure 15, which would be classified extensive damage. Although it does not threaten the life safety of building occupants, it does require significant and costly repairs. This type of deficiency is common in single-family residences in the City of Victoria.

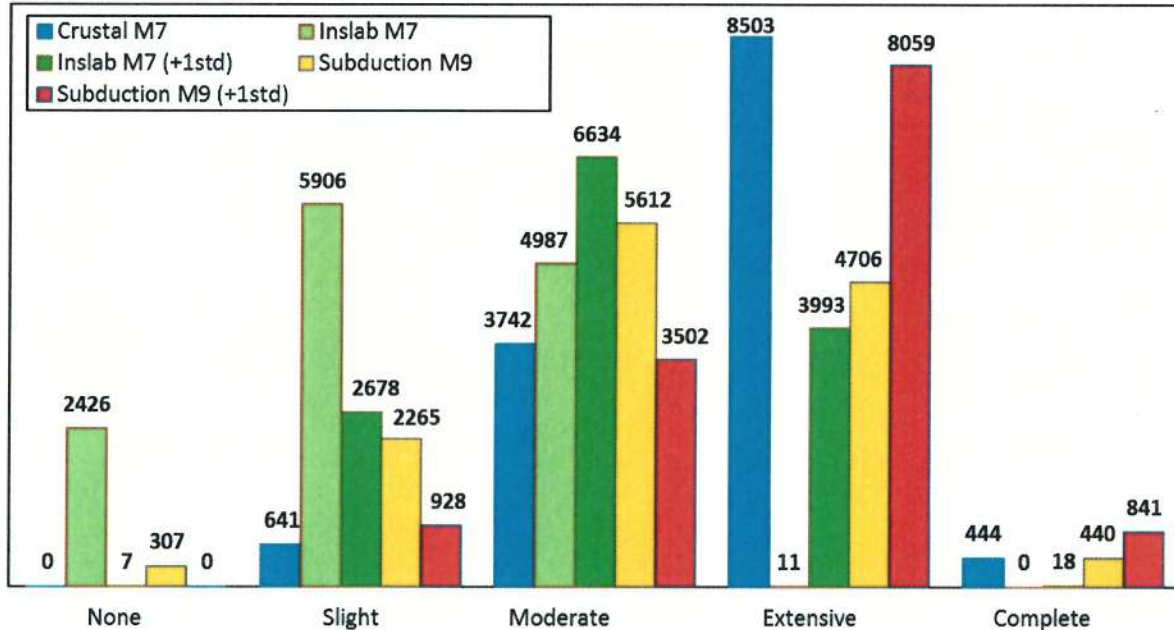
Figure 21: Number of Buildings at each Damage State for the Five Earthquake Scenarios

The inslab event produces the lowest levels of shaking with the city, and consequently produces the lowest amount of damage. However, large amount of moderate and slight damage may still be observed, which may not pose a threat to life safety in the city, but will almost certainly impose large monetary demands. These events are quite common in the area (three events equal to or greater than magnitude 6.8 have occurred in the last ~70 years), and as such, the City of Victoria should be well prepared for this level of shaking. The maximum credible inslab

event creates large amounts of damage, but because these levels of shaking from an inslab event are very unlikely, these results from this event are not critical.
