Heritage Advisory Panel Report For the Meeting of May 14, 2024

To: Heritage Advisory Panel **Date:** April 17, 2024
From: Kristal Stevenot, Senior Heritage Planner
Subject: **Heritage Alteration Permit Application No. 000251 for 674, 676, and 678 Battery Street, 675 and 685 Niagara Street, and 50 Douglas Street**

50 Douglas Street, 675 & 685 Niagara Street and
674-678 Battery Street
Rezoning No.00810

RUTLAND RESIDENCE

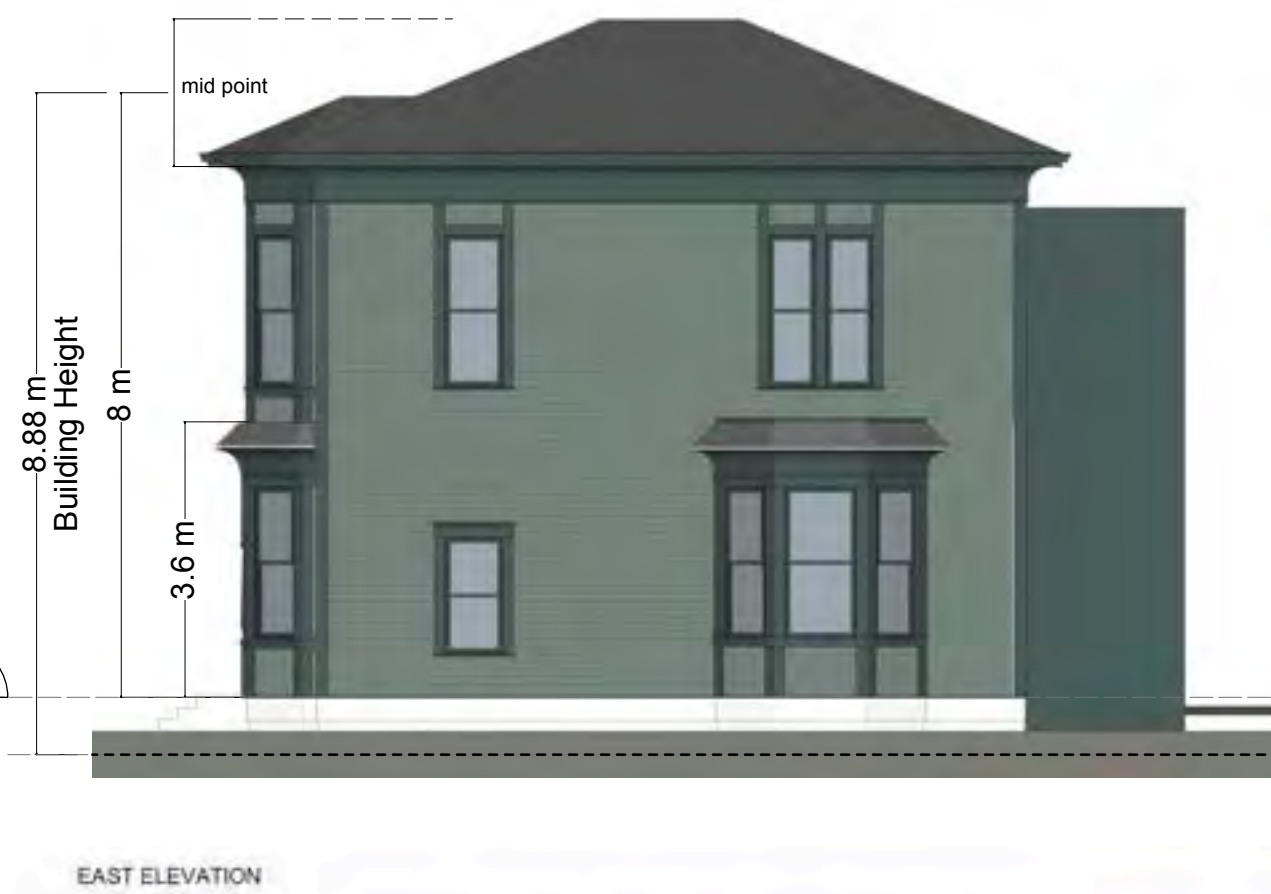
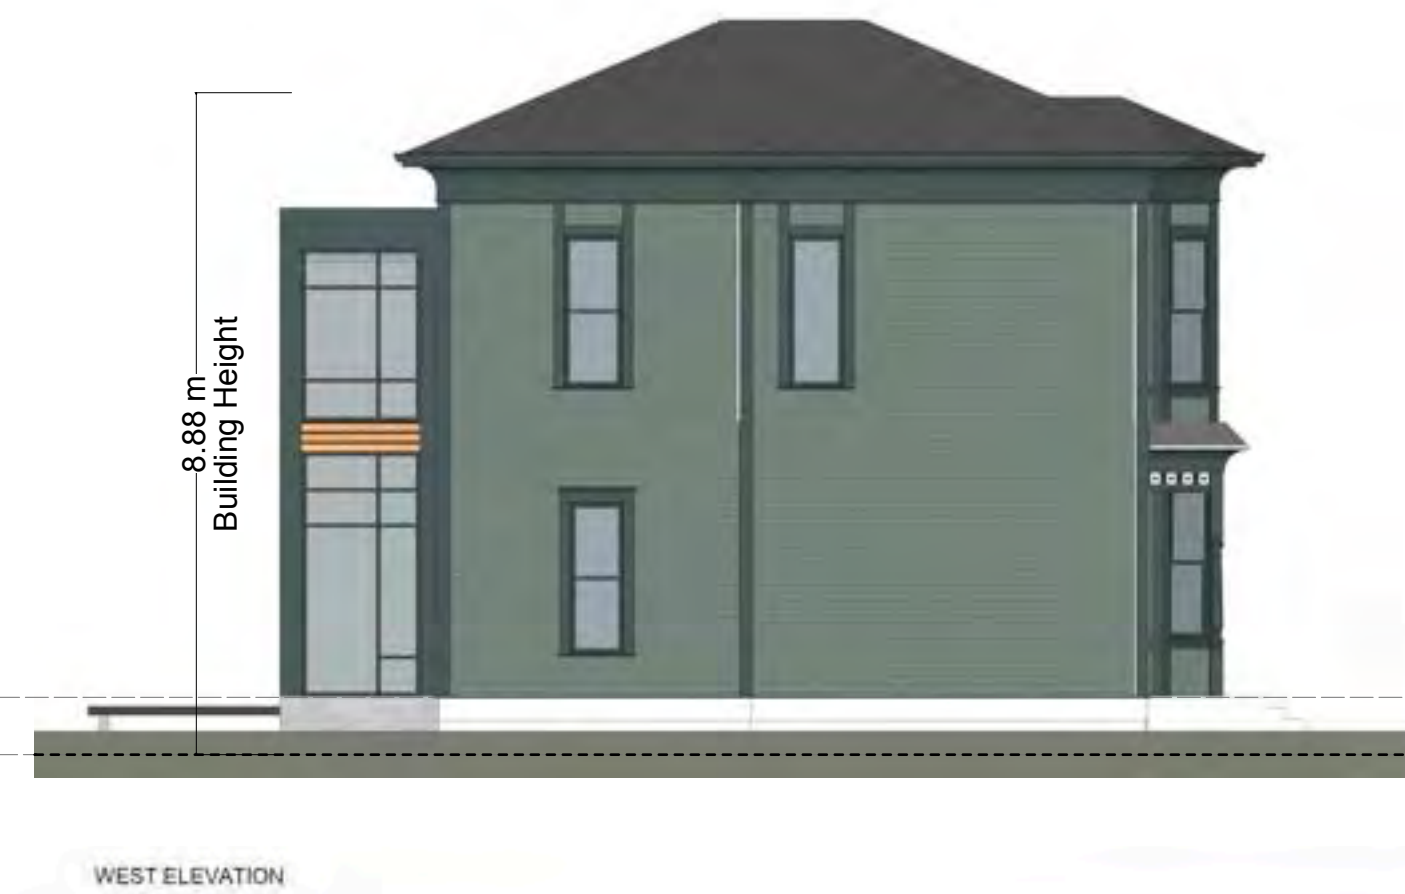
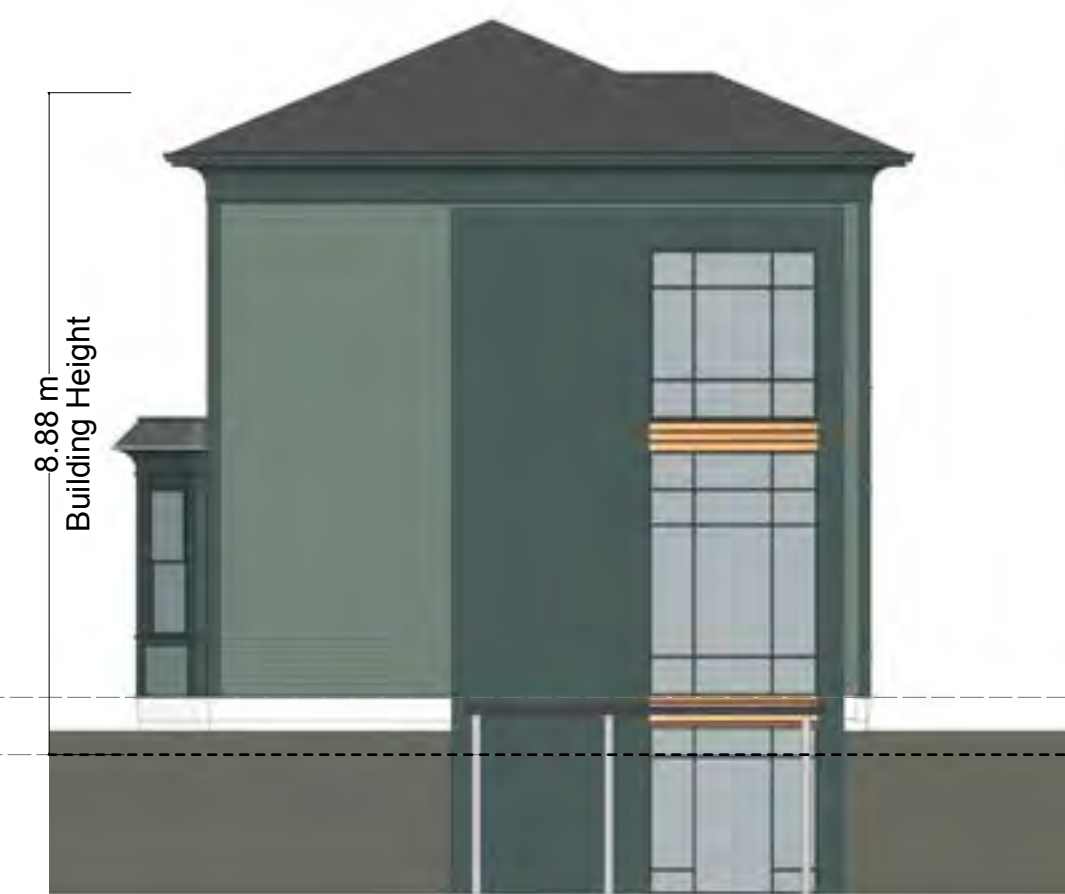
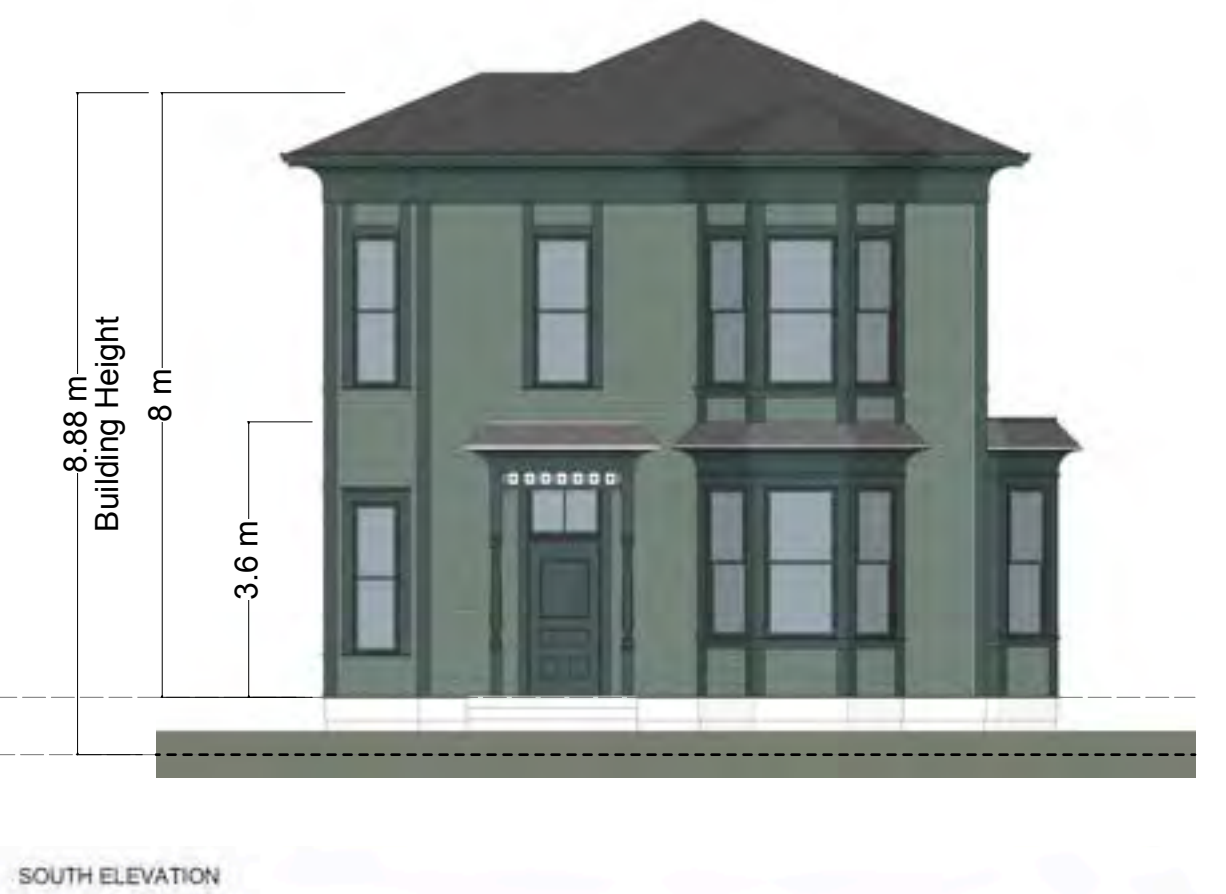
HERITAGE HOUSE Scale: As Noted

COLOUR LEGEND	
ELEMENT	COLOUR
WOOD SIDING	PENDRELL VERDIGRIS
WOOD WINDOW SASHES, WOOD COLUMNS, ROLLED COVES	PENDRELL GREEN
WOOD WINDOW TRIM	GLOSS BLACK

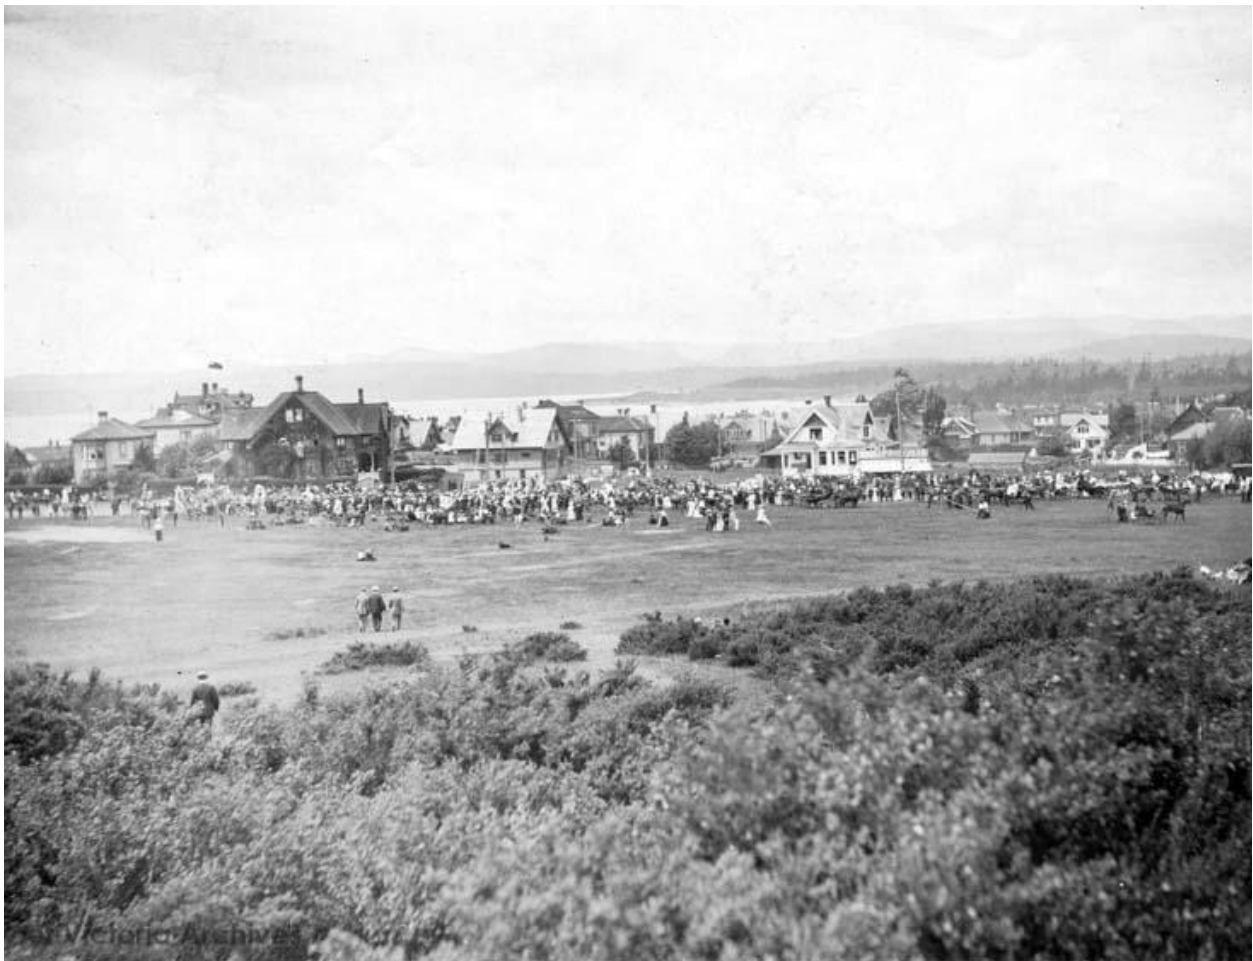
Rutland Residence, visible in the background, from Beacon Hill Park, City of Victoria Archives (CoVA) M07149, 1907

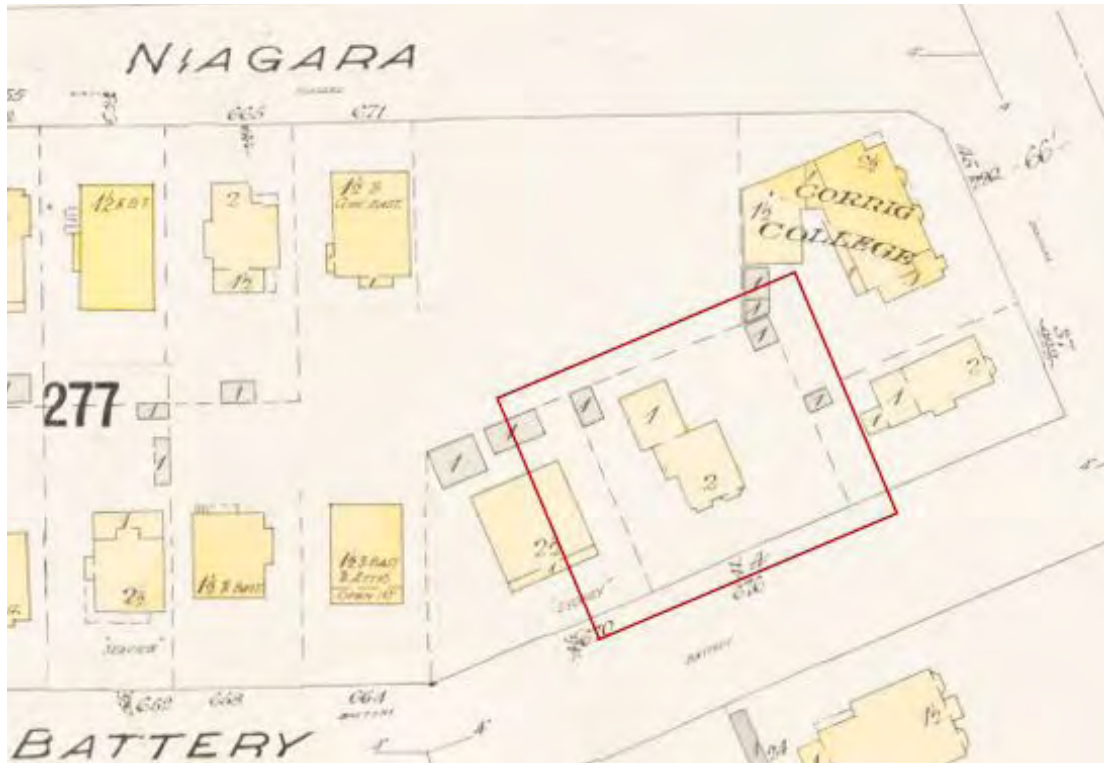
Fire Insurance Plan, 1903 (revised 1905 and 1909), Sheet 85, Rutland Residence outlined

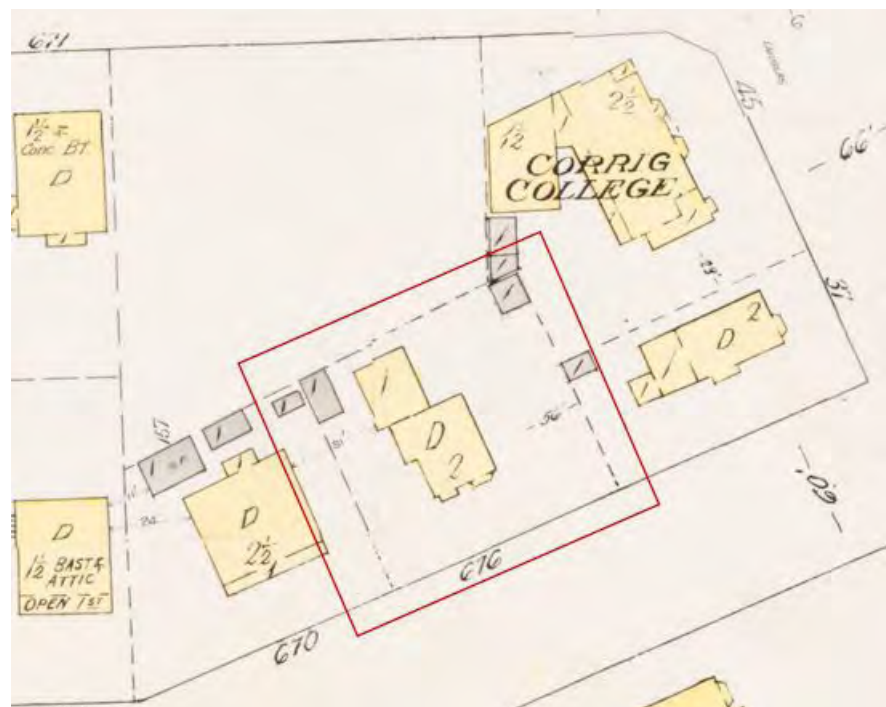
Fire Insurance Plan, 1911 (revised 1913), Sheet 69, Rutland Residence outlined

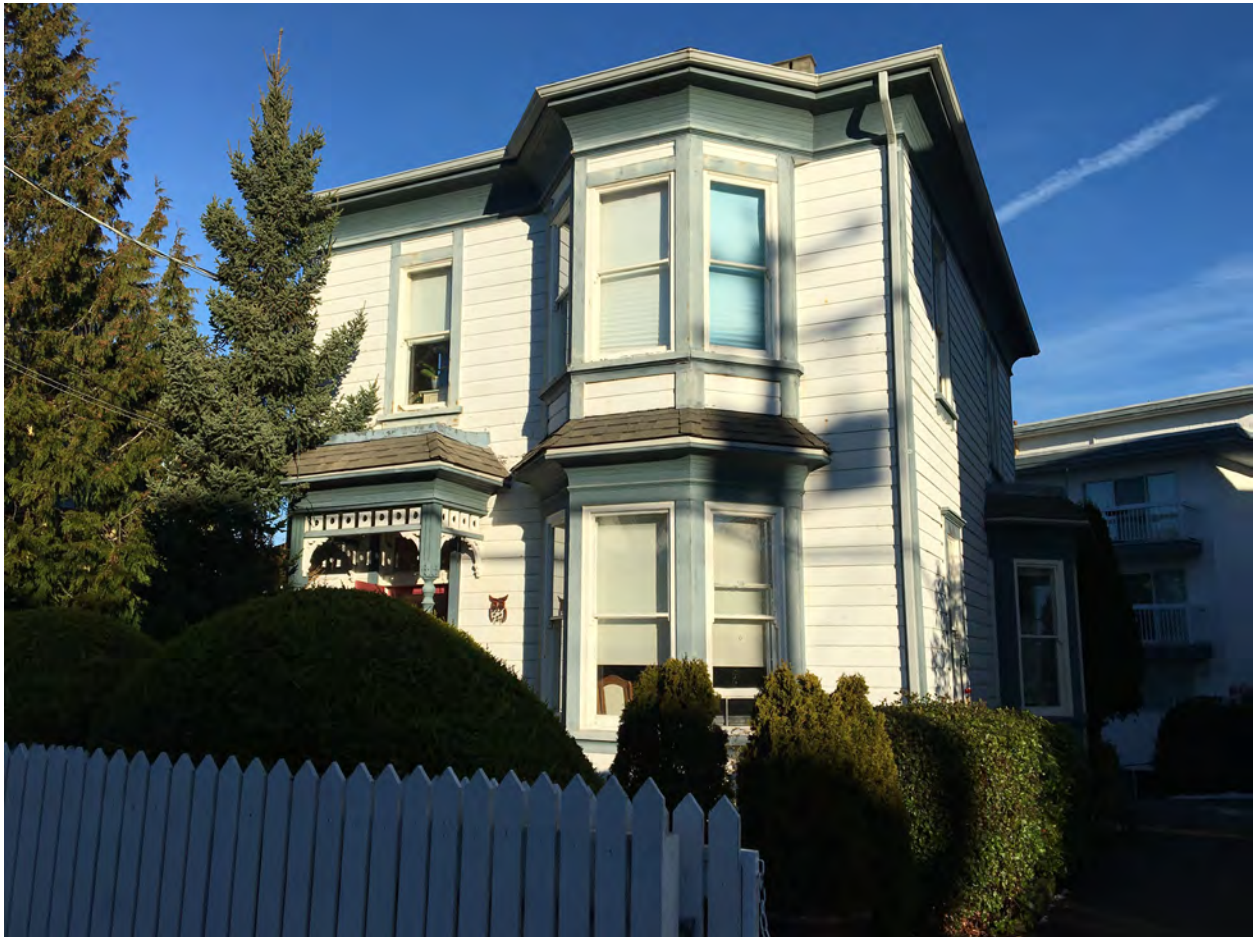
A preliminary condition review of the Rutland Residence was carried out during a site visit in January 2022. A visual review of the exterior of the building was completed with no destructive or invasive testing completed. The recommendations for the preservation, restoration, and rehabilitation of the historic Rutland Residence are based on the site review and archival documents that provide valuable information about the original appearance of the historic building.

The historic structure and exterior facades should be protected from movement and other damage at all times during any demolition, excavation and/or construction work. Install monitoring devices to document and assess cracks, staining, or any other signs of possible settlement or moisture damage.

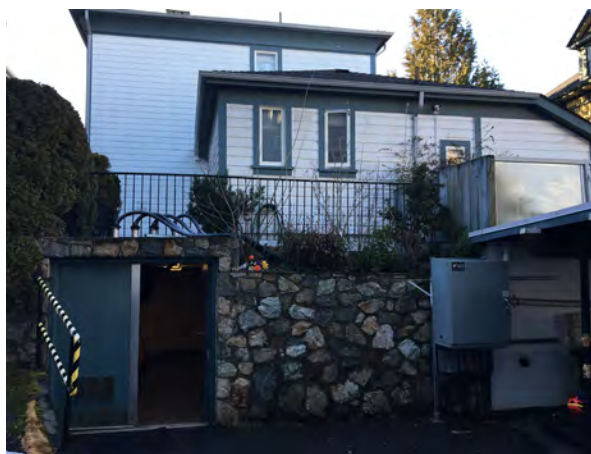
Built in 1889 in the historic James Bay neighbourhood of Victoria, the Rutland Residence remains in its original location on Battery Street facing south. Boasting continuous residential use, the house will continue to provide residential accommodation through four renovated rental units. As part of the proposed overall redevelopment of the site, the Rutland Residence will be retained in its original

location, restored to its original historic appearance, and rehabilitated as required to accommodate the surrounding multi-unit residential development. As new architecture is proposed, all new construction will be considered a ‘new addition’ to the historic building and must follow the appropriate recommendations outlined in **Standard 11**, ensuring new construction is “physically and visually compatible with, subordinate to, and distinguishable from the historic place.” All new buildings should be physically and visually separated, as possible, from the house’s exterior, preserving the residential scale and appearance of the house on the property.

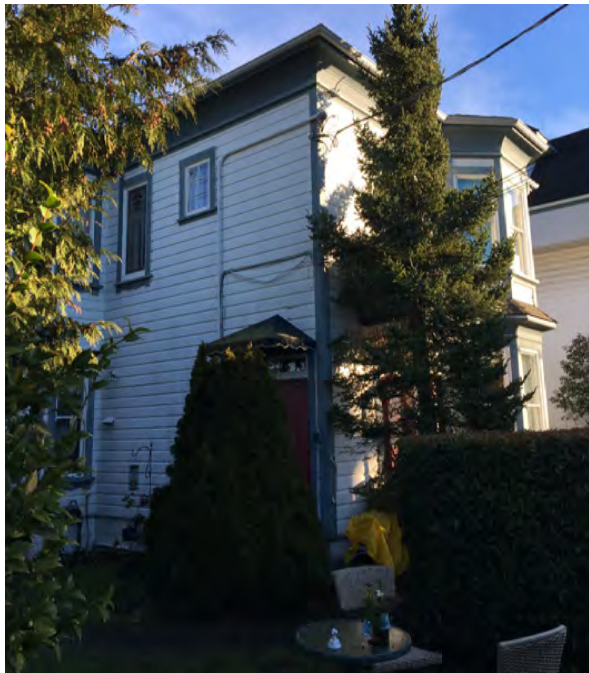
The historic Rutland Residence is built in wood-frame construction and is clad in wooden drop siding with dimensional wooden trim and cornerboards. The residence is a prime example of late Victorian-era Italianate architecture, exemplified by shallow eaves with rolled coves, pent roof separating the two storeys of the hexagonal bay on the front façade with shallow eaves and rolled coves, off-centre hipped-roof entry porch with rolled coves, scroll-cut screen and brackets, and lathe-turned columns with square fluted capitals and bases, window crown mouldings, and scroll-cut window aprons, which are character-defining elements of the historic building.

Extant original siding material and trim appears to be in fair condition with evidence of weathering and localized damage; further onsite investigation will be undertaken to establish a thorough condition assessment of original fabric. As part of the proposed rehabilitation scheme, original existing exterior materials and detailing will be preserved, wherever possible, and any altered exterior elevations or finishes will be restored and repaired or replaced in-kind to match original as closely as possible, where required. To ensure prolonged protection of the historic resource, all exterior surfaces should be repaired and refinished according to the approved heritage restoration colour scheme.

- Preserve the wood-frame structure of the original 1889 house.
- Preserve original exterior character-defining elements, including exterior cladding and Italianate-style detailing and trim.
- Restore appearance of original exterior walls where altered.
- Conduct full condition assessment to determine extent of required repair work. Repair damaged material where required, utilizing approved restoration in-kind replacement techniques, and replace in-kind where missing or damaged beyond safe use. Ensure all new material matches historic original as closely as possible in material, detailing, and appearance.

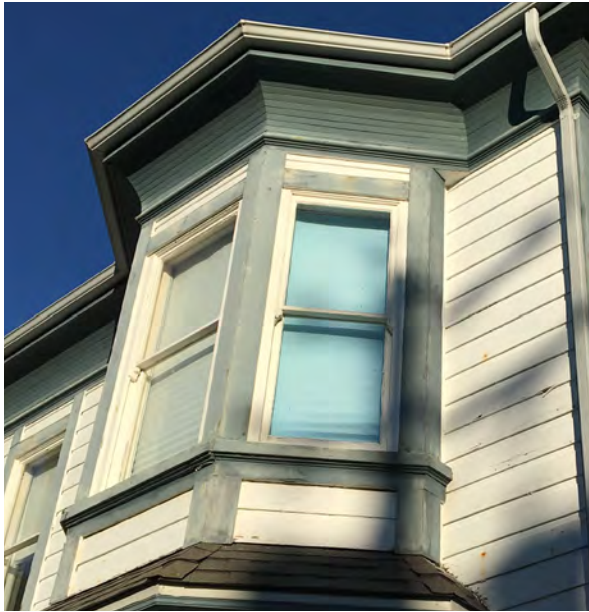
- Remove later north-side addition and restore north side elevation. Dependant on the integrity of the wood frame structure, original altered exterior walls should be retained and rehabilitated where required following removal of the later additions.

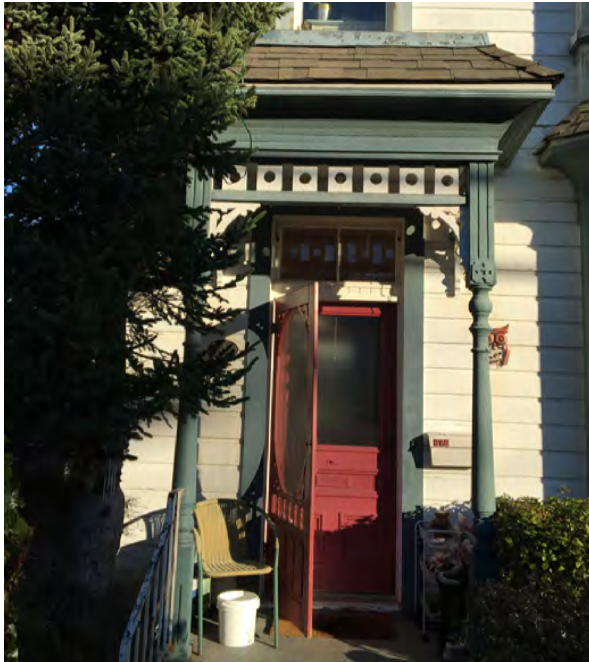
The Rutland Residence features a simple shallow hipped roof with three original internal chimneys, which are character-defining elements of the historic structure that will be preserved. The character-defining roof displays details typical of the Italianate style, including shallow eaves with rolled coves seen along the perimeter of the primary roofline as well as over the ground floor bay windows and entryway, and an off-centre hipped-roof over the entry porch, detailed with rolled coves, scroll-cut screen and brackets, supported by lathe-turned columns with square fluted capitals and bases. The original shingle cladding has been replaced with asphalt shingles. The roof appears to be in fair condition with evidence of weathering and localized damage to exterior materials, which will require more thorough review when access is available. As part of the overall rehabilitation scheme, the existing original roof structure will be retained and

rehabilitated as required. Original character-defining elements, including the shallow eaves with rolled coves, will be preserved, and any missing, altered, or damaged character-defining elements or original fabric will be repaired and/or replaced in-kind, as required.

- Rehabilitate and/or restore altered elements following removal of north-side addition. Restore to its original two-storey 1889 configuration.
- Preserve original material, where possible, including wood trim, rolled coves, cladding, structural elements, detailing, etc. Repair in-kind, or replace where too deteriorated for safe use.

- Design and install adequate rainwater disposal system and ensure proper drainage from the site is maintained. Wood gutters with galvanized steel downspouts are recommended. Aluminum in appropriate colours is also acceptable. Paint or provide specification of drainage system elements according to colour schedule devised by Heritage Consultant.
